B and B Inspections

December 10, 2012

Report

Address
Any City, Ky.

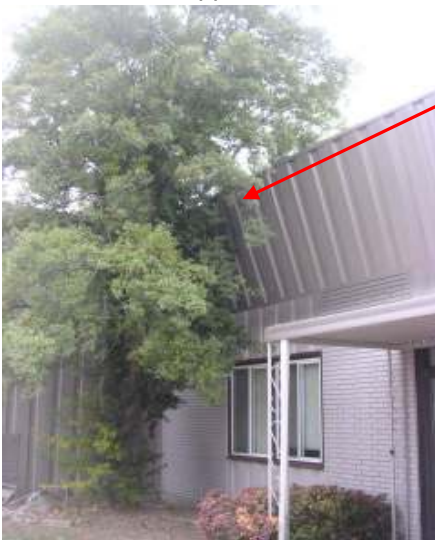
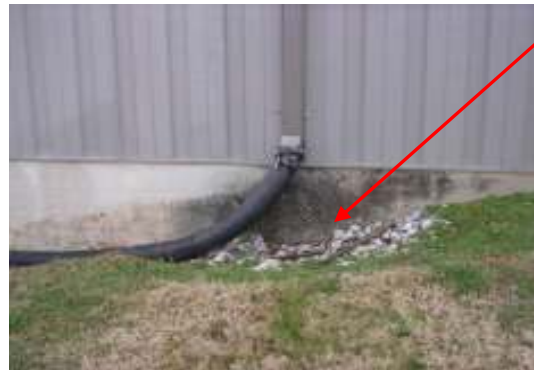
Rear left corner has erosion. A drain tile has been installed to prevent further erosion. Tree causing damage to fascia between HR and Sales areas. Fascia supports broken, and no longer secure.

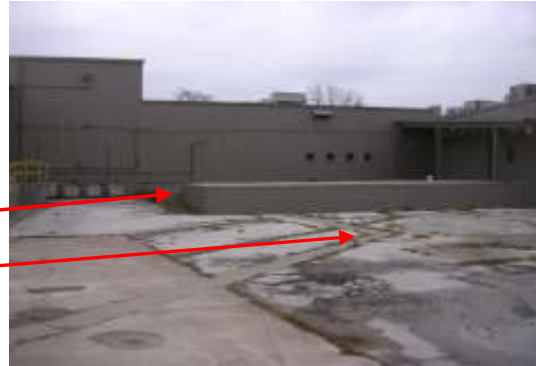
Some demolition areas not completed, right side.
Evidence from all the construction
phases exist.

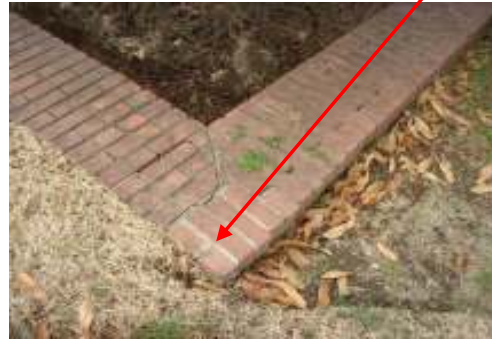
Corner near front door has loose and cracked bricks.

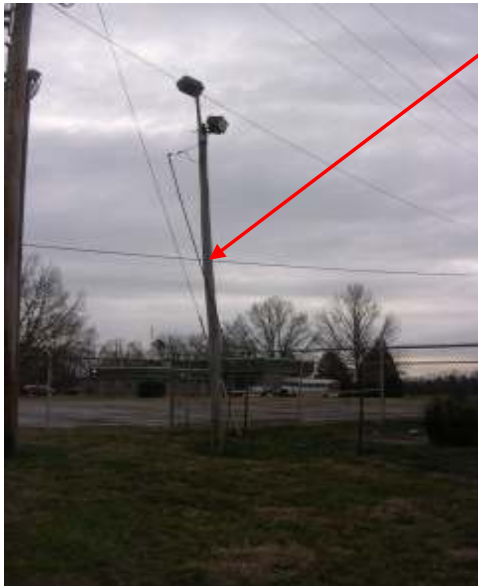
Pole on left side leaning and conduit damaged.

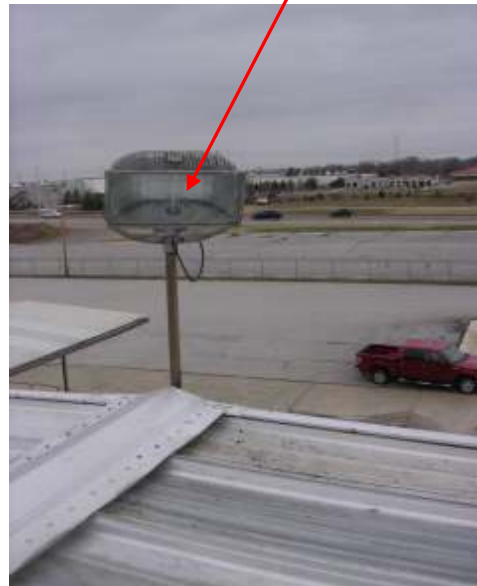
Lot light aiming to roof.

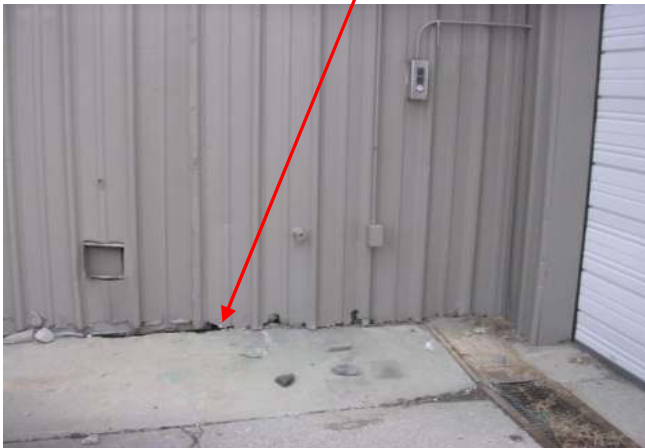
Left side rusting at bottom.

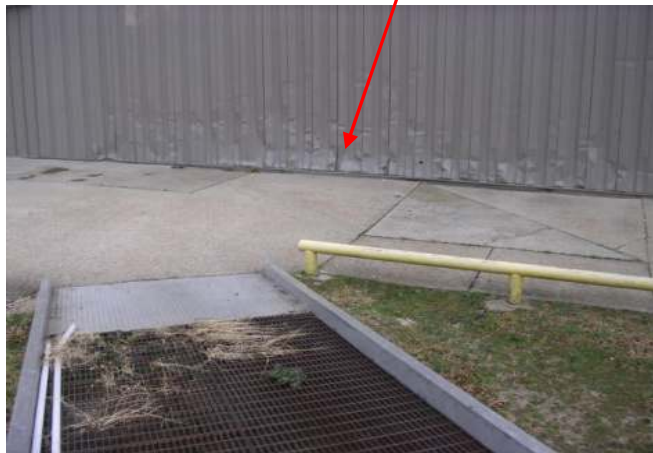
Left side near the inclined ramp damaged.

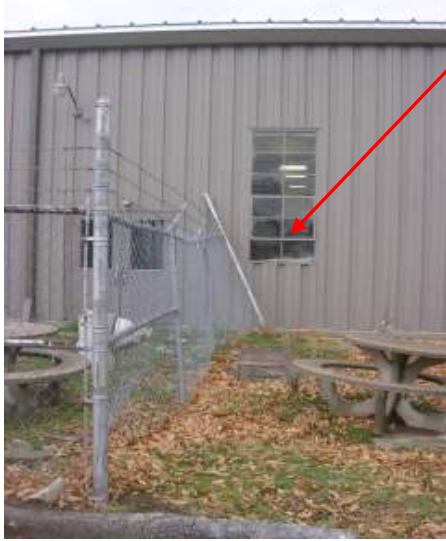
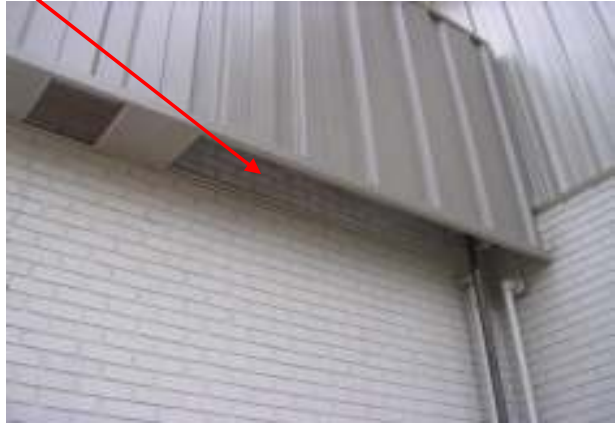
Above the gas meter at the engineering front wall soffit pieces missing.

Tilting window near fence left front was not closed.

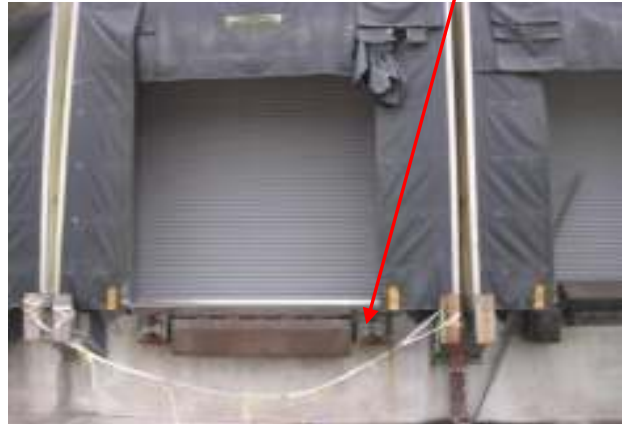
Several bumpers missing, damaged, rear side.

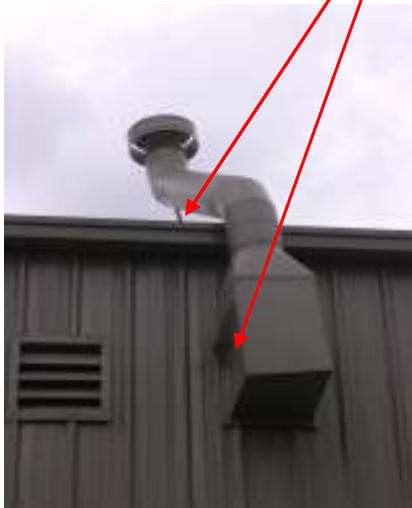
Side exhaust vent bent mount.

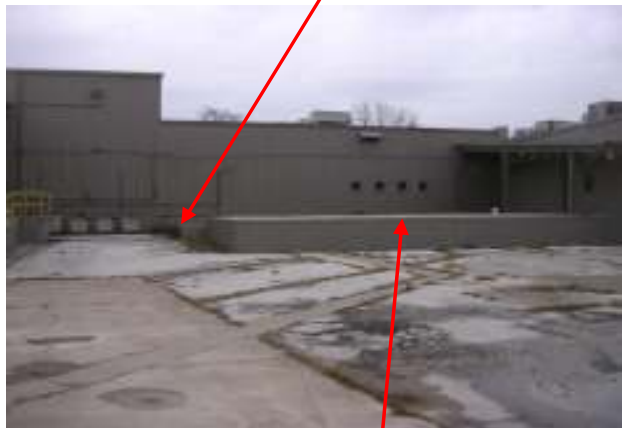
Right side missing standard steps.

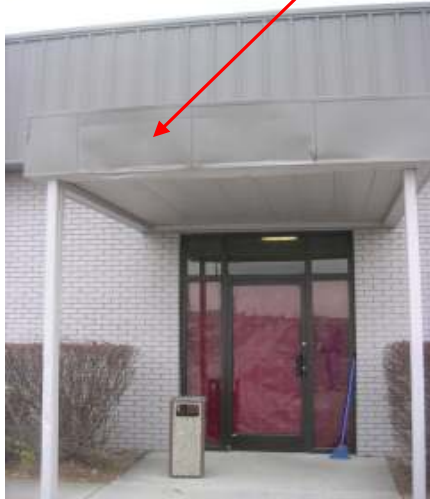
Awning at left Sales door damaged.

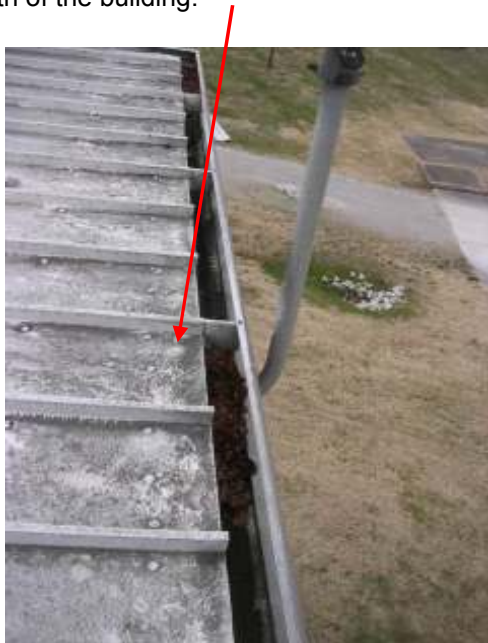
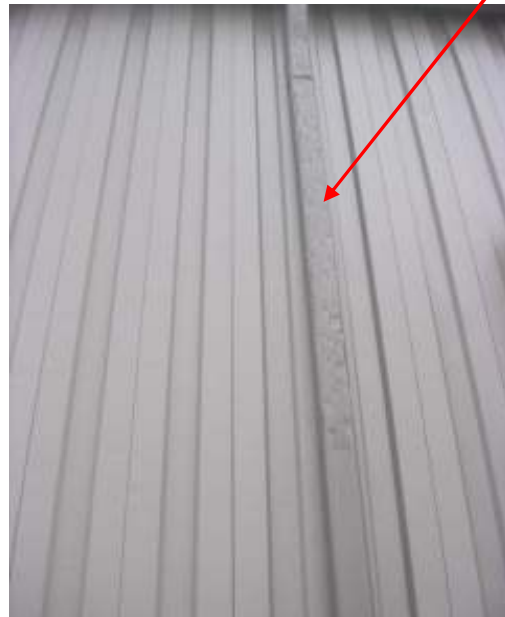
The rear gutter on the rear warehouse had debris through most of the length of the building.

Hail dents apparent on rear facing downspout surfaces.

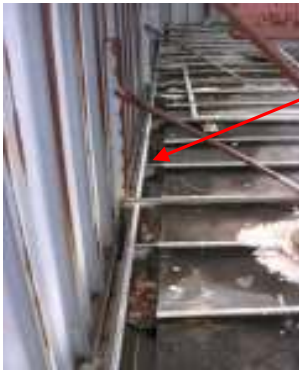
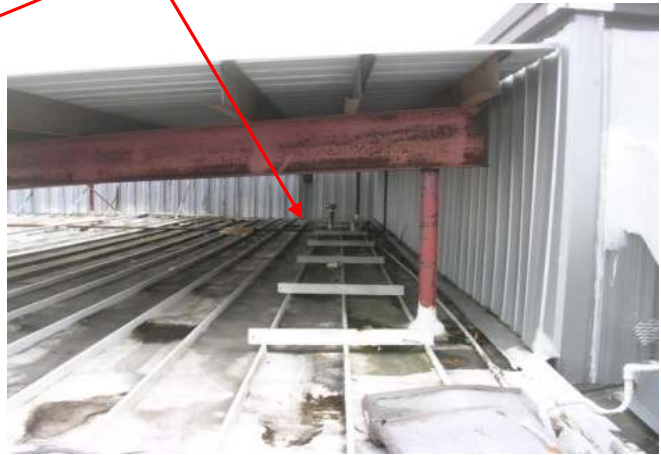
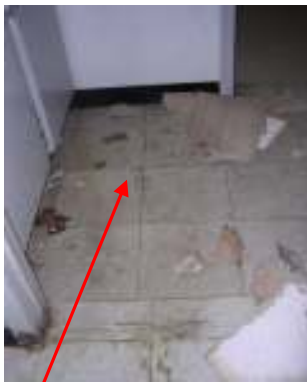
The gutters/roofing could easily gather debris to the right of the front door and then water would leak into the office area.

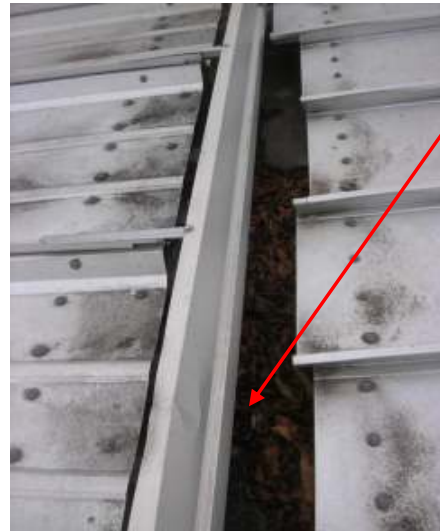
The gutter between warehouses had debris on the left side.

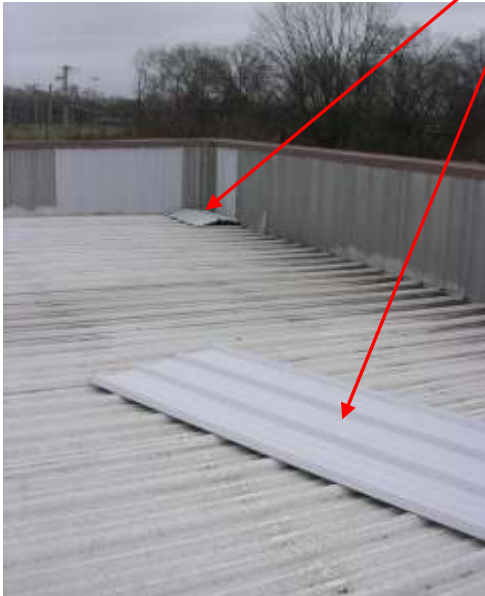
An active leak was found in the HR area near the sink area with a first aid area.

Cleanup of unused, unattached metal siding from recent repairs was not done to the left of the front door

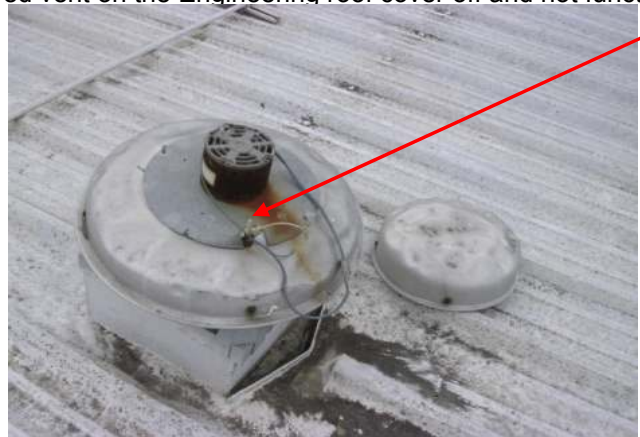
One powered vent on the Engineering roof cover off and not functional.

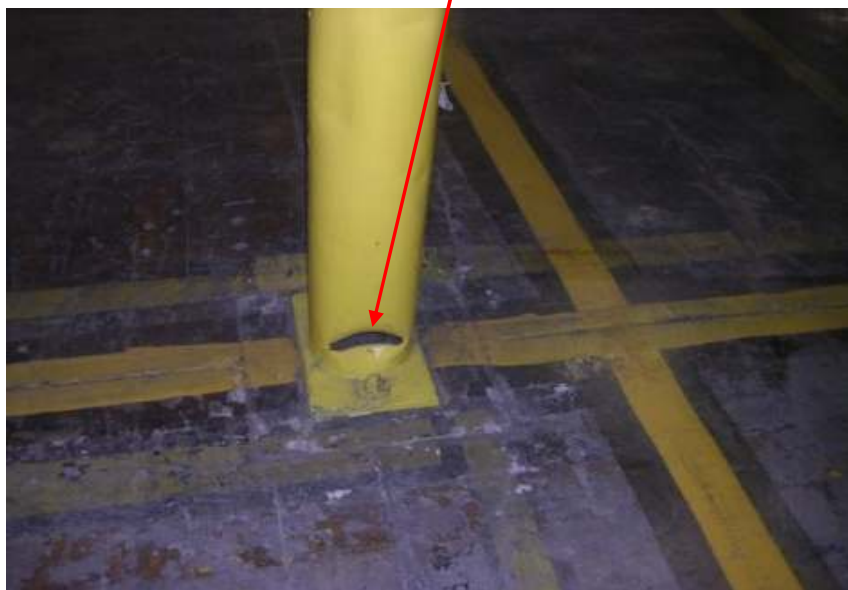
Condition: Functional	Items: Structure Type:	Metal columns and beams. Metal siding on all but offices. Offices have brick siding.
Defective	Structure:	Warehouse column damage exists on about 14 columns. Starting at the right front with column A1, and proceeding to I15 at the rear left corner, A1, A4, A8, A9, C14, F4, F12, G14, H6, have holes mostly from fork trucks. The concrete is likely no longer secure under columns G1, G5, H6. Beams are rusted at the bottom to the point of not providing the intended strength at columns C15, E15, I7, and the front right column of the front warehouse.
Functional Functional	Foundation: Differential Movement:	Concrete None noted. One small vertical crack noted on the rear wall of the indoor truck unloading ramp. Monitor for change.
Functional Functional Defective	Floor/Slab: Sub floor: Moisture:	Concrete Concrete first floor. Second floor engineering metal structure. Staining noted in many areas from prior roof leaks, gutters formerly full of debris, and AC vents being closed. These all appeared inactive. Several actively wet areas were apparent. One from an AC condensate drain, not covered in this section. Several were from plumbing, not covered in this section. The OSB wood wall at the rear of the second warehouse was holding as much moisture to peg my moisture meter. This is likely from the debris in the gutters allowing the water to drain into the wall.

An example of a damaged column.

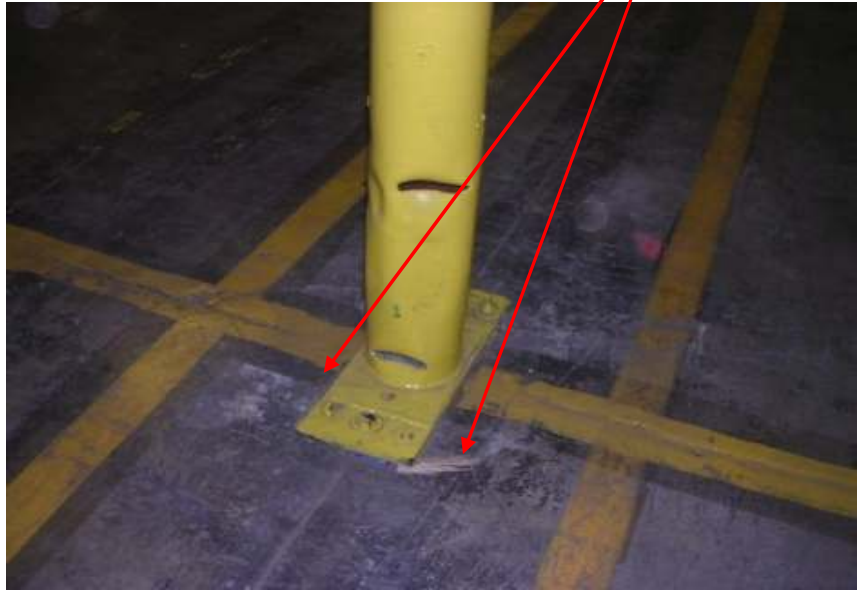
An example of damaged concrete under a column.

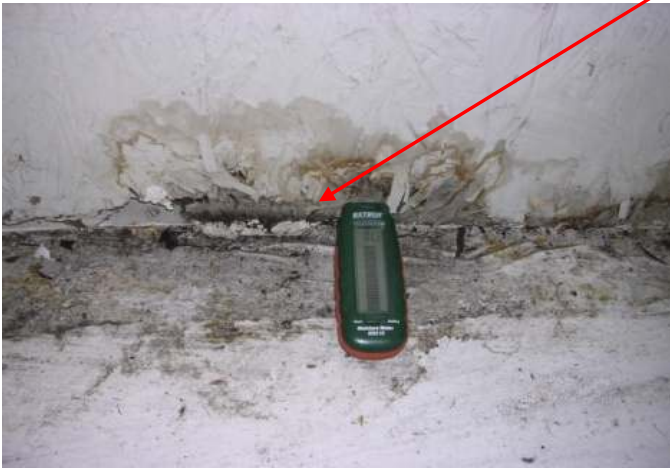
The OSB wood wall at the rear of the second warehouse was holding as much moisture to peg the moisture meter (above 44%).

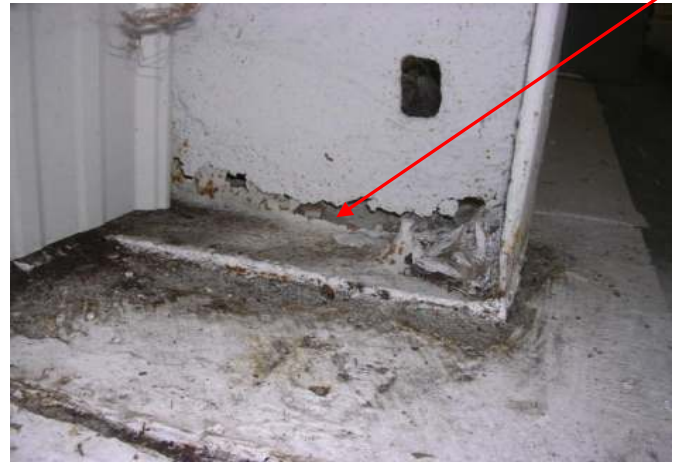
An example of a rusted through column at the bottom.

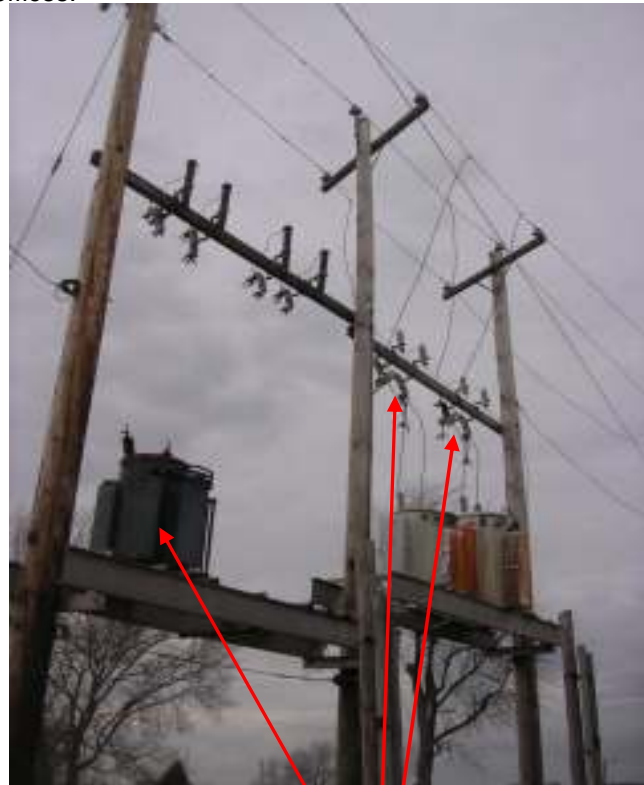
On left middle side one transformer is not connected, and two transformers have the fused knife switches disconnected.

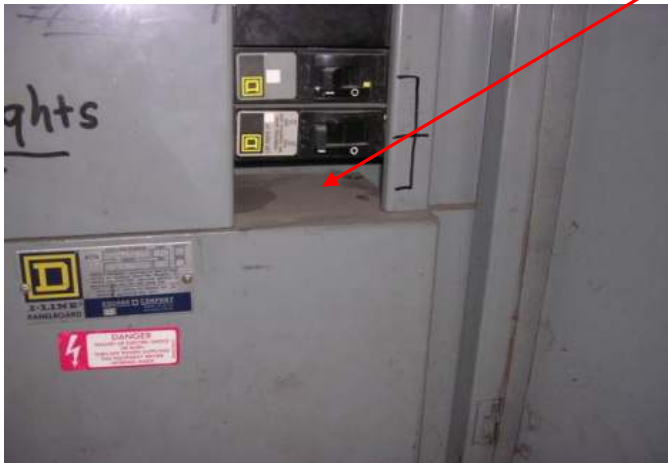
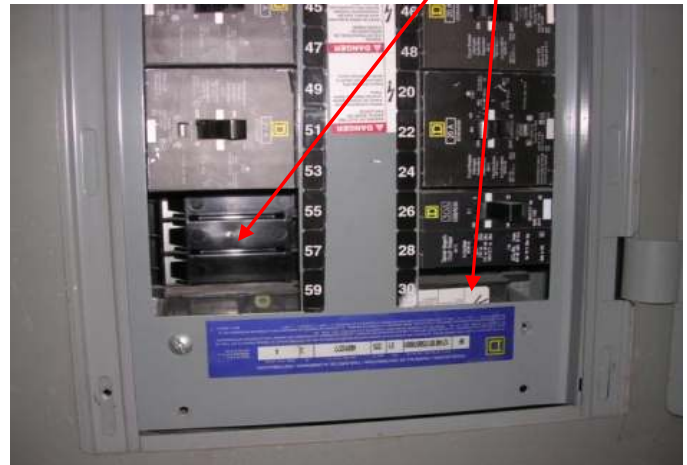
Subpanel B and panel to the rear of Panel A missing covers.

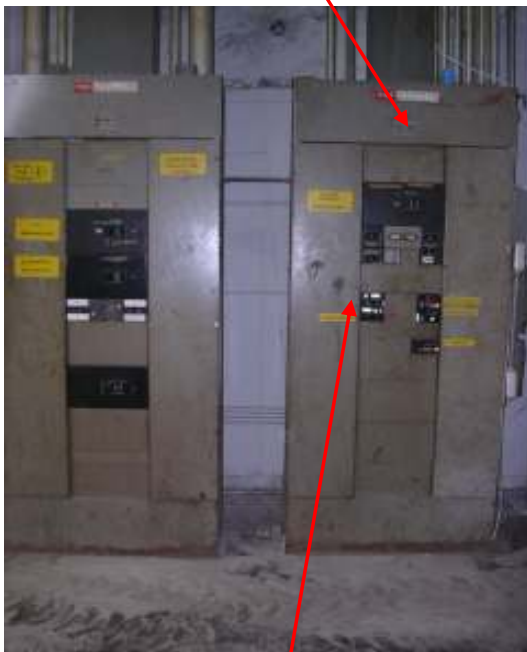
Main Breaker not present:

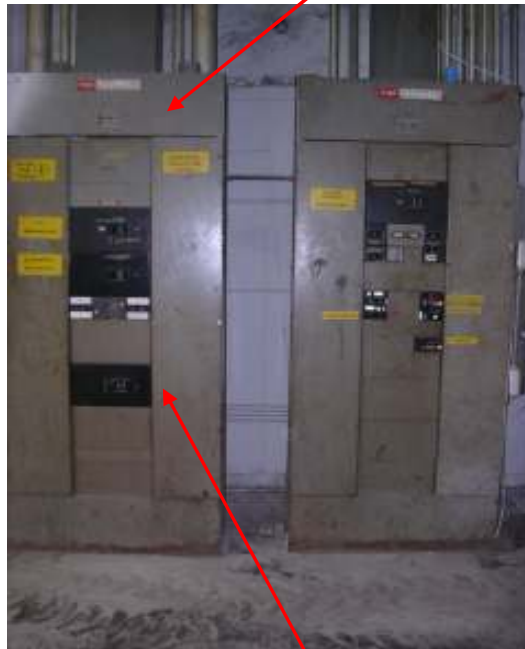
Main Breaker not present:

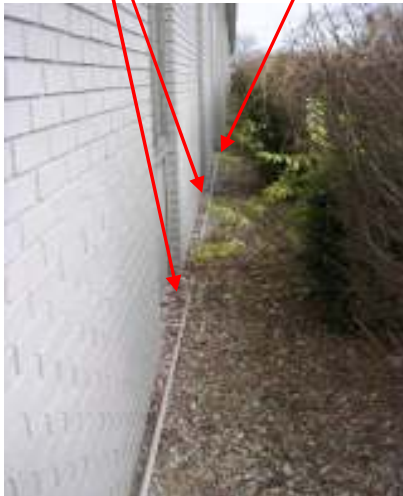
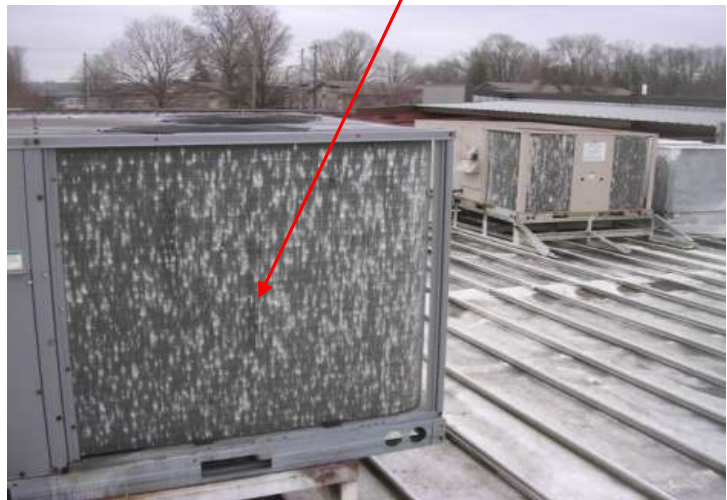
Items:
Hail Damage: Most AC units have hail damage. The fins that face the rear of the building on most of the units have hail damage.
Gas heater plumbing: Several offices connected, many not.

Capped off. Gas line ran.

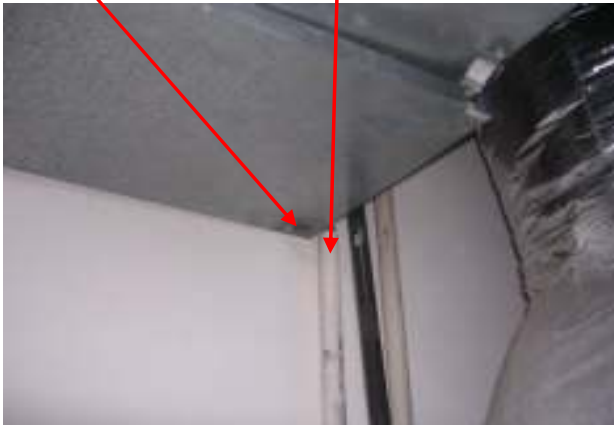
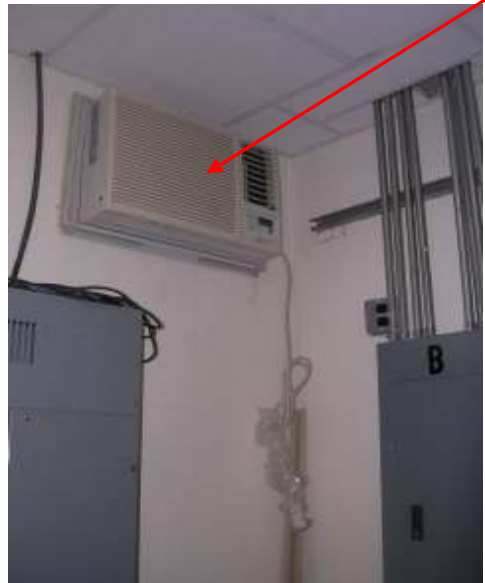
Pan not connected to PVC drain.

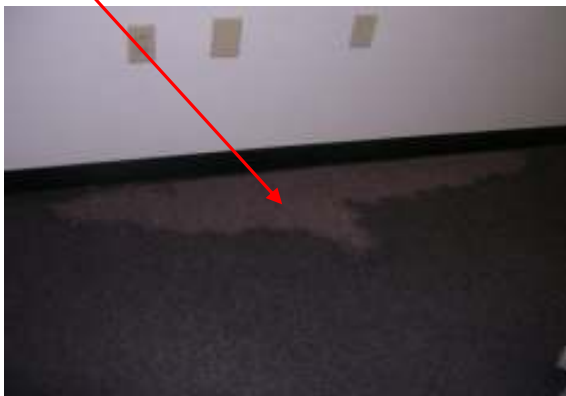
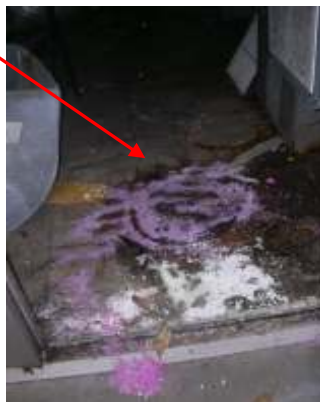
Caused floor of room for HVAC units 1E, 1F, 1G, 1I, and 1H to be soaked, and water drained to conference room.

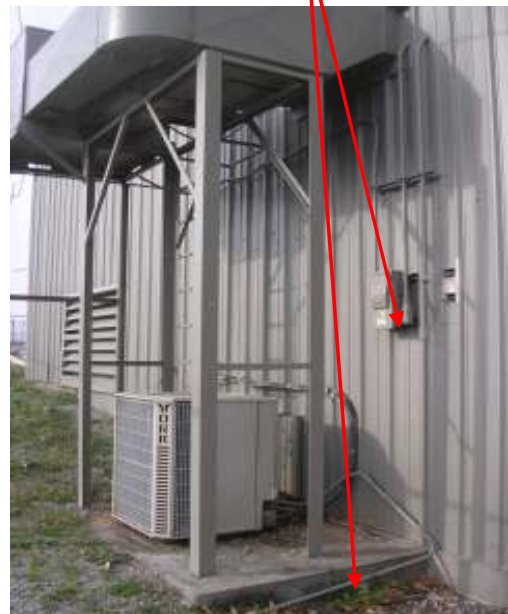
The York unit on the pad is disconnected from power.

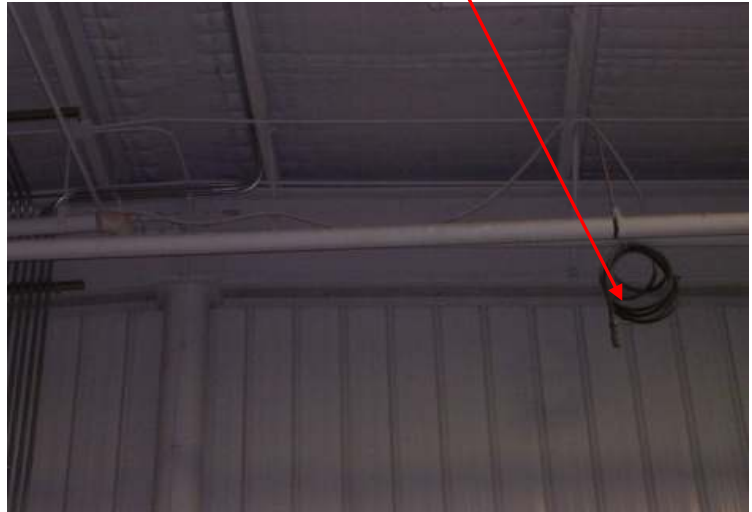
Functional Defective	Items: Water Lines: Vent Pipes:	Mostly Copper Cast/PVC. Pipe broke in two at the front left column of the front warehouse. This is about a 5 inch cast pipe broken in two. I failed to take a picture of this.
Functional Defective	Drain Pipes: Gas lines:	Cast/PVC A hose ran in the rafters near the left wall of the warehouse. This appears to be on and from a gas line.

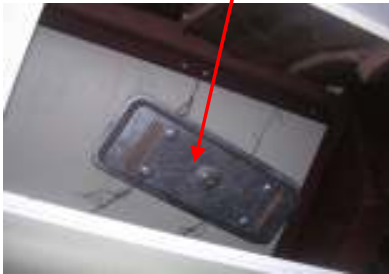
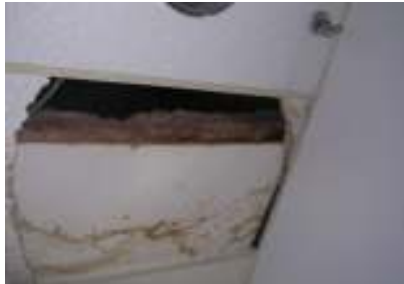
Catch pan for leak.

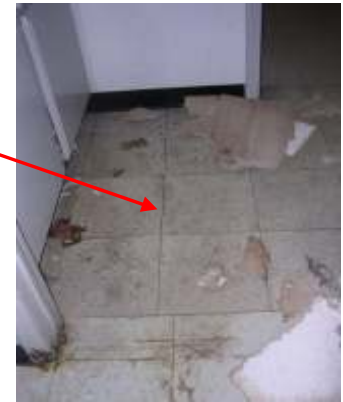
Suspended tiles. Many stained, broken tiles.
 Drywall/paint. Many damaged areas.
 Carpet, many stains and worn areas. Active roof leak in sink area damaging tiles.
 Wood.
 Fixed and sliding.
 Many lights out.

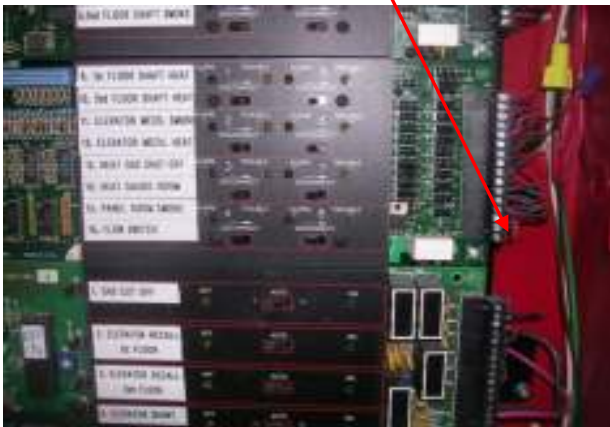
Bypassed input 16. Flow Switch.

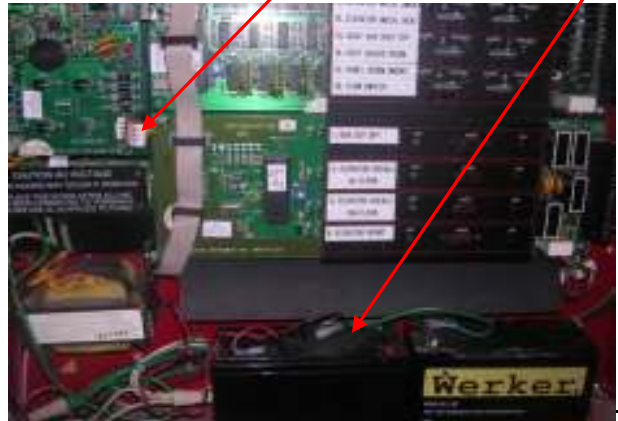
Disconnected from power and from backup battery.

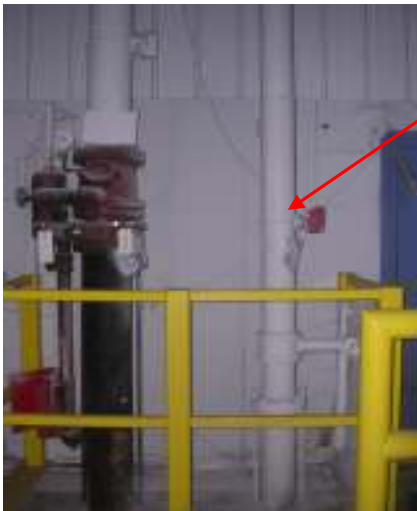
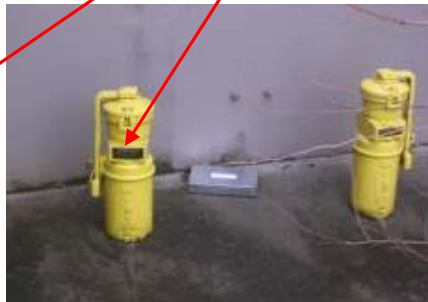
One inactive riser was still pressurized with no valves to drain/flush this riser and header on a regular basis.
