# B and B Inspections

## Report

February 27, 2012

**Address**  
**Any City, Ky.**

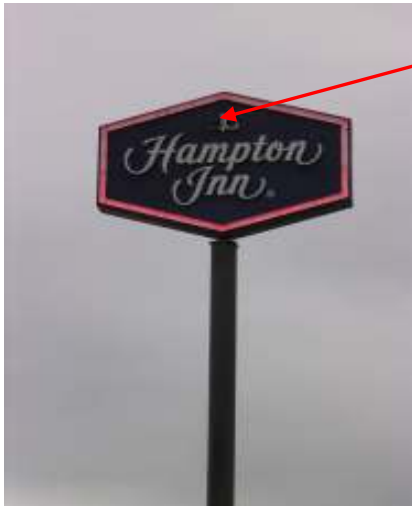
**Signage:** Some paint missing.

Some paint missing.

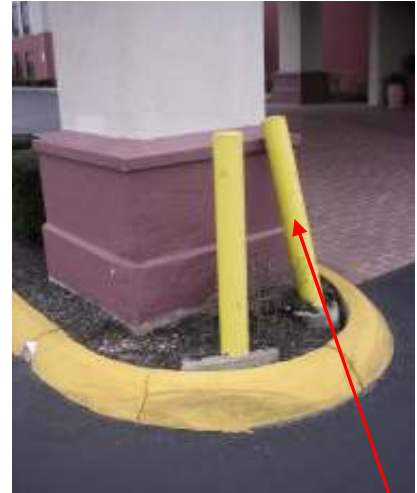
Two areas have bent balusters.

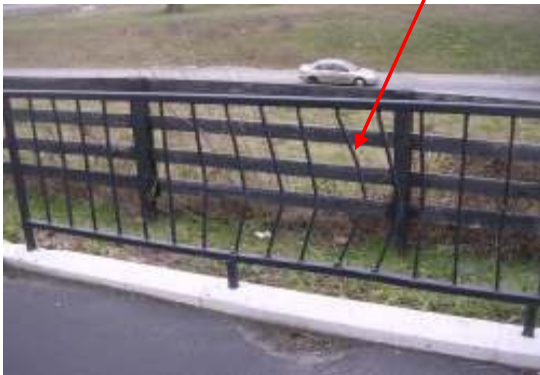
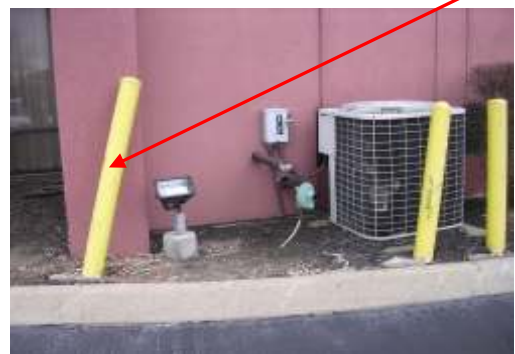
**Bollards:** 8 bollards are loose and no longer vertical near the front entrance.

All 8 bollards are loose and no longer vertical.

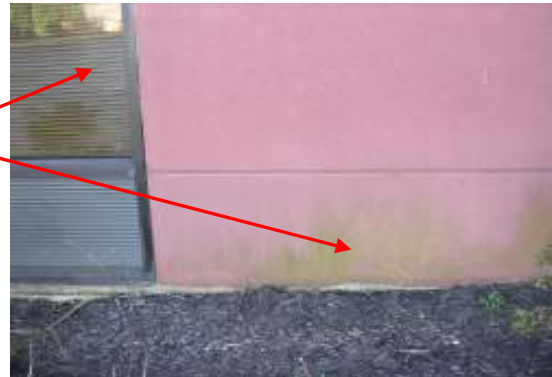
Approximately 25% of all windows in this building have very visible staining inside the panes of glass. The seal between the panes is broken. Approximately another 25% of the windows have staining that is just starting to be visible. The seal in all of the windows will very likely fail in a short period. These windows cannot be repaired and have to be replaced to have clear windows.

Cloudy/stained window. Typical of many.

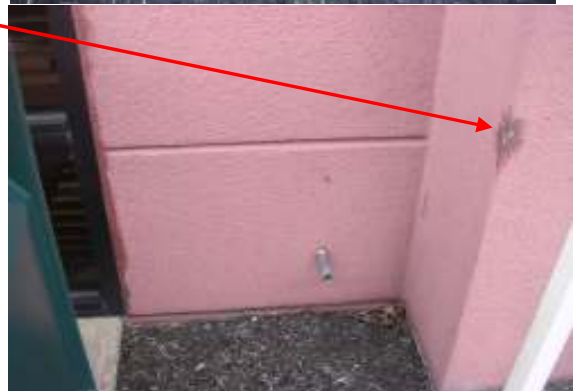
Synthetic stucco covering - Drivit is the common brand name to call this covering. Several areas have recent repairs, and paint. Some paint does not match well. Mold present on the front side.

Repair work on damaged Drivit.

[Exterior only. This exterior siding system should be inspected for internal moisture buildup. This is an expensive inspection procedure, and is offered as an option.](#)

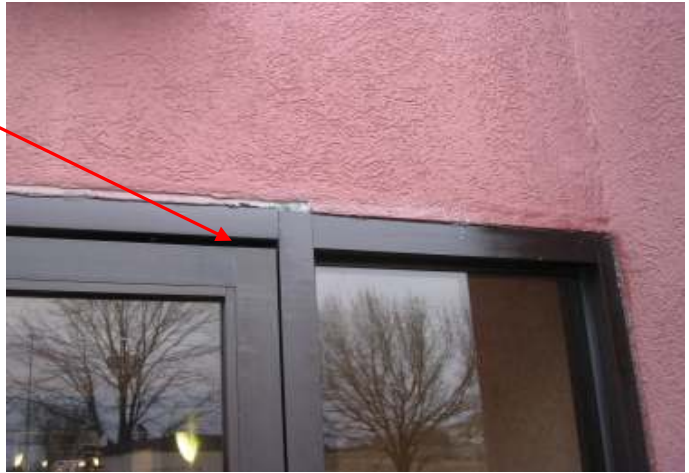
The left side exit door does not fit well.

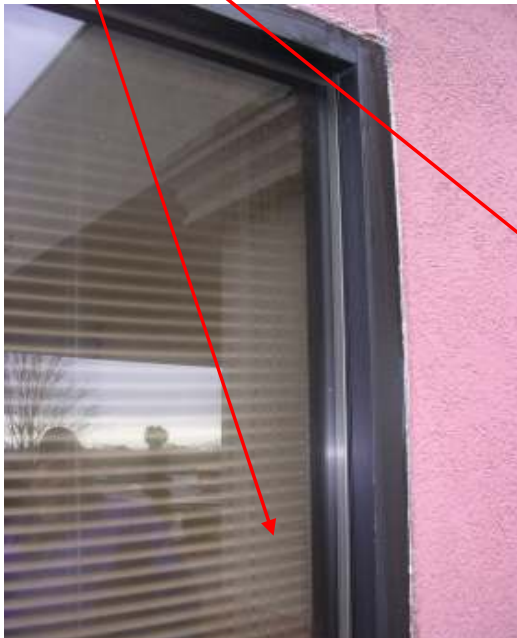
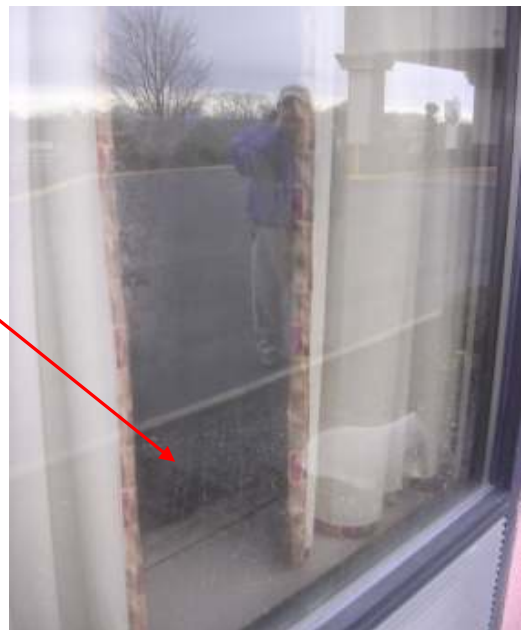
Windows throughout this building have seals that are broken which cause the staining inside the panes. This staining is much more visible from the inside.

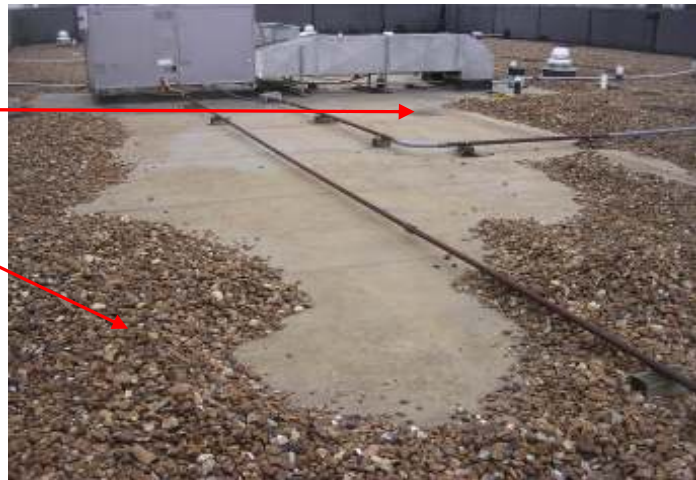
Recent repair to a hole in the EPDM covering.

Gravel moved to find the leak.

This is around the left side HVAC unit, that used to have a plugged condensate drain. That drain is likely now working.

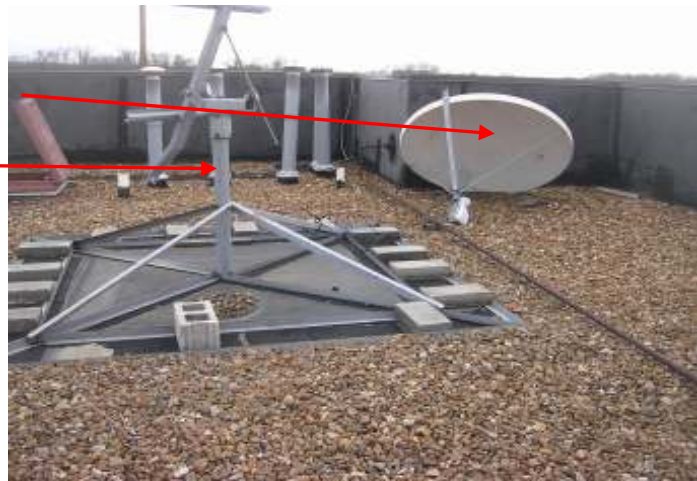
Broken off of mount and laying loose on the roof.

Mount for dish.

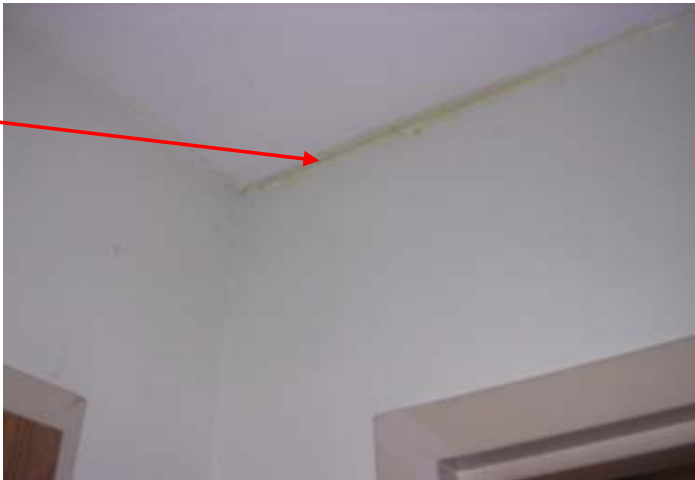
This is an example of an internal wall that has some water stains from a previous leak. About 5% of the rooms have this type of staining.

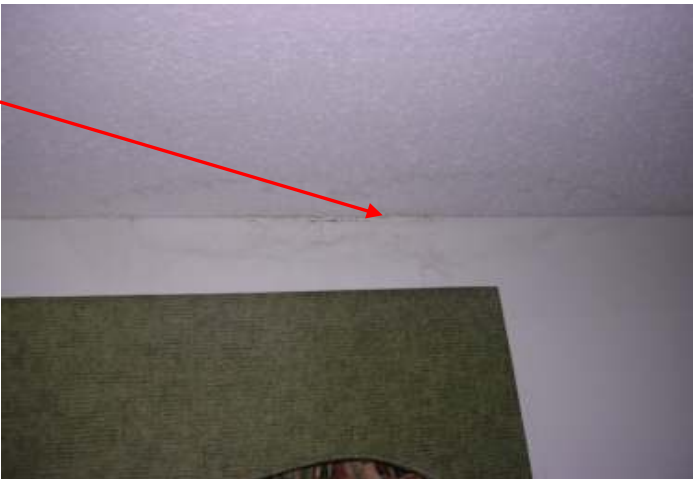
This is an example of an external wall that has some water stains from a previous leak. About 15% of the rooms have this type of staining.

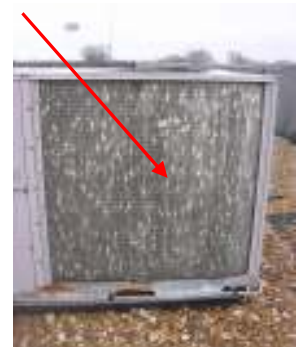
<b>Manufacturer:</b>	Bryant	<b>Approximate Age:</b>	15 years
<b>Type:</b>	Self contained rooftop	<b>Capacity:</b>	10 ton cooling.
<b>Area Served:</b>	Left side, general areas.	<b>Temperature Differential Cooling:</b>	NI
<b>Fuel:</b>	Electric/propane	<b>Temperature Differential Heat Mode:</b>	NI

<b>Condition:</b>	<b>Items:</b>	
Functional	<b>Heat Operation:</b>	Adequate. This unit was maintaining the setpoint of the thermostat. This unit serves such a large area of this hotel and testing the temperature differential would have affected current guests.
Conditional	<b>A/C System</b>	The A/C system should not be turned on until it has been higher than 65F for 24 hours. This should be checked for 15-20F differential between the supply and return registers when it can be operated. Hail damage has occurred to the condenser coils.
Functional	<b>Condensate Removal:</b>	PVC to internal roof drain.
Functional	<b>Thermostat:</b>	Hallway, right side, of second floor.
Functional	<b>Flue Pipe:</b>	Metal
Functional	<b>Flue Lines:</b>	Metal
Functional	<b>Fuel Tank:</b>	Propane tanks.
Functional	<b>Filter:</b>	Clean, changed on 2/23/2012.

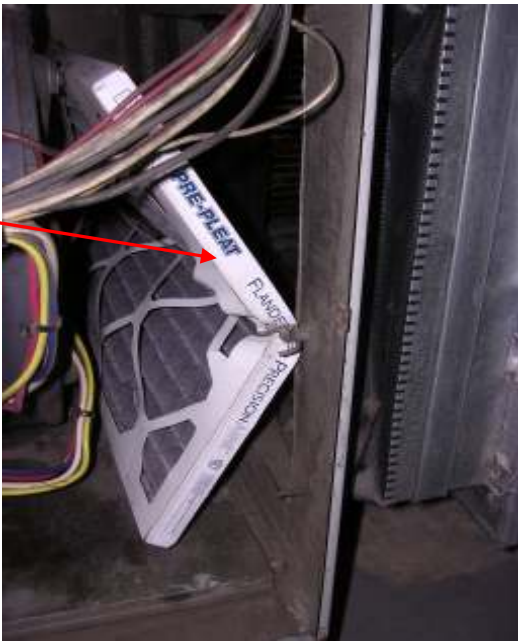
The filter does not have a housing that secures the filter in place. This filter is dirty, has collapsed, and is no longer functioning.

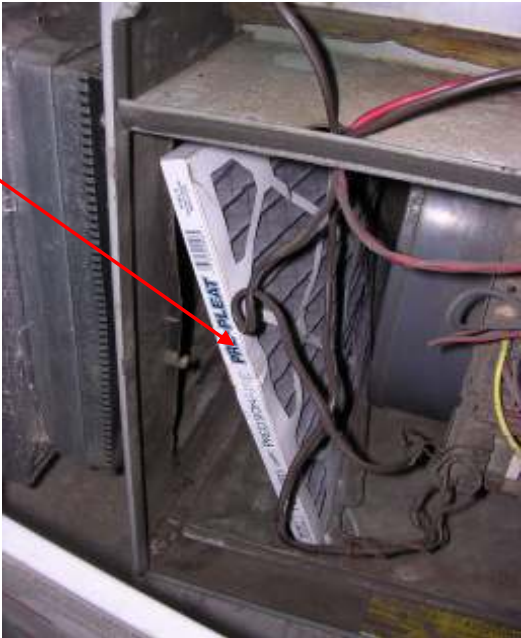
The filter does not have a housing that secures the filter in place. This filter is serving very little good.

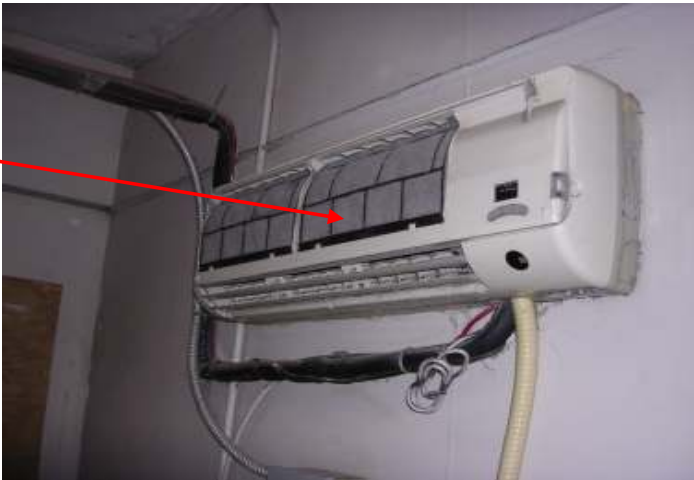
This filter should be black in color. It has a thick coating of dust.

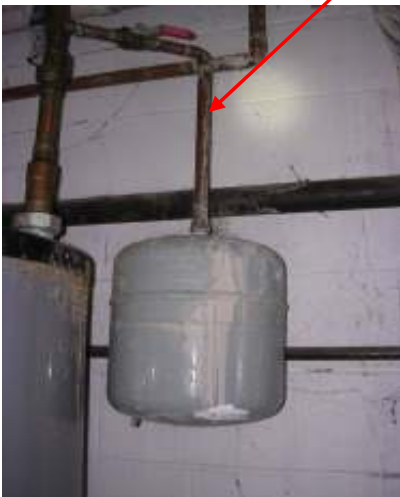
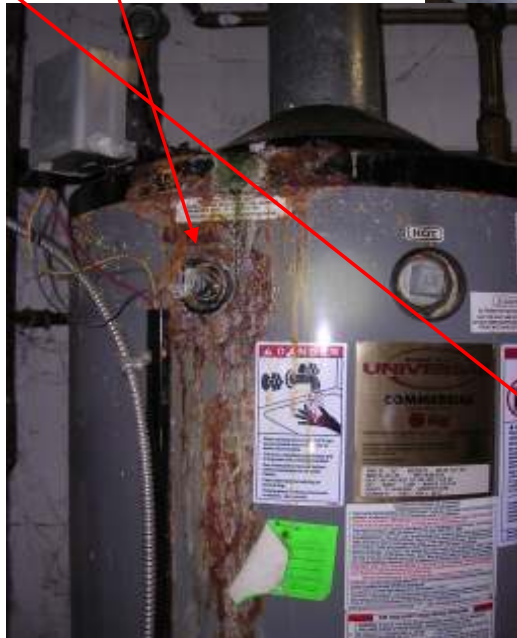
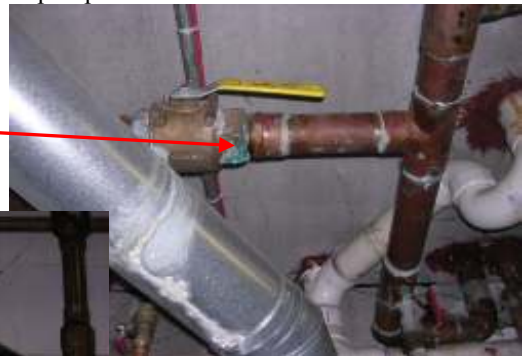
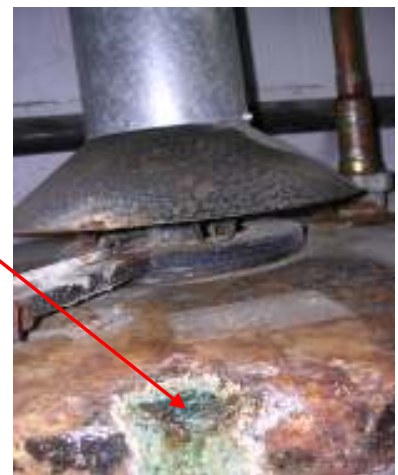
<b>Condition:</b> Functional <b>Defective</b>  Functional Functional Functional NP <b>Defective</b>	<b>Manufacturer:</b>	Rheem-Ruud	<b>Location:</b>	First floor maintenance room
	<b>Fuel:</b>	Propane	<b>Approximate Age:</b>	15 years
	<b>Items:</b>			
	<b>State Inspection:</b>	1997		
	<b>Operation:</b>	Gas shut off. Water leak in the plumbing above this heater causing damage to this heater.		
	<b>Flue Pipe:</b>	Metal		
	<b>TPRV and Drain Tube::</b>	To concrete floor.	NI	
	<b>Capacity:</b>	91 gallons	<b>Temperature:</b>	
	<b>Circulation loop pump:</b>	Not clear whether the 3rd floor pump serves this area also.		
	<b>Surge tank:</b>	Not secured in a safe manner.

Water leak at this point in the 1st floor maintenance area above the water heater.  
Water dripping to this point.  
Causing this damage to the water heater.

Not secured in a safe manner.

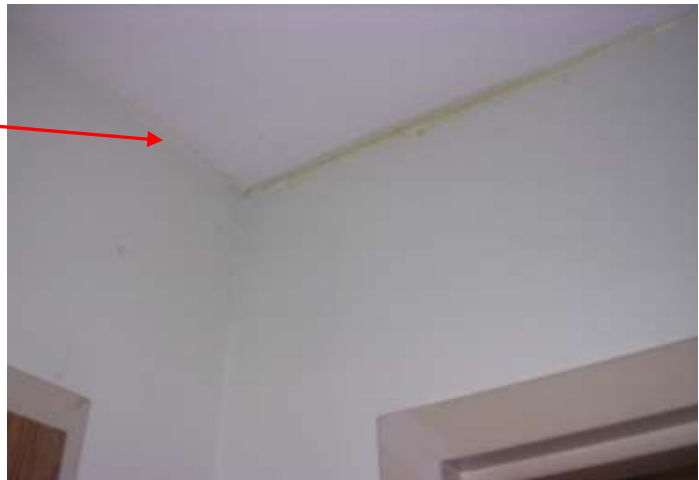
This is room 227.

This is typical for the stains that are on the ceiling for the rooms listed on the next page.

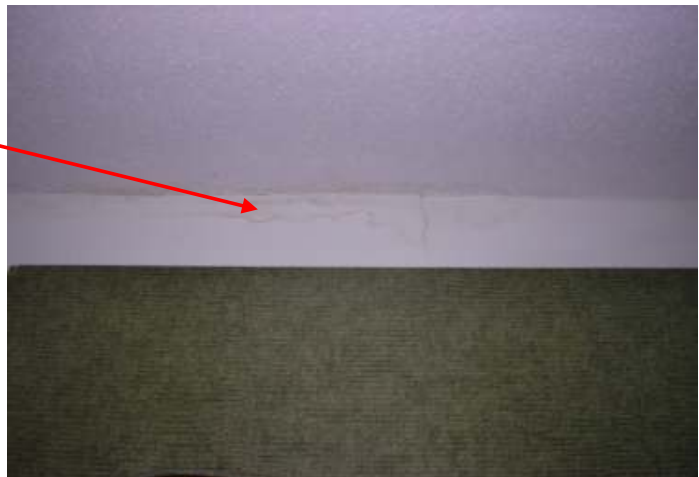
This is typical for the stains that are on the walls for the rooms listed on the next page.

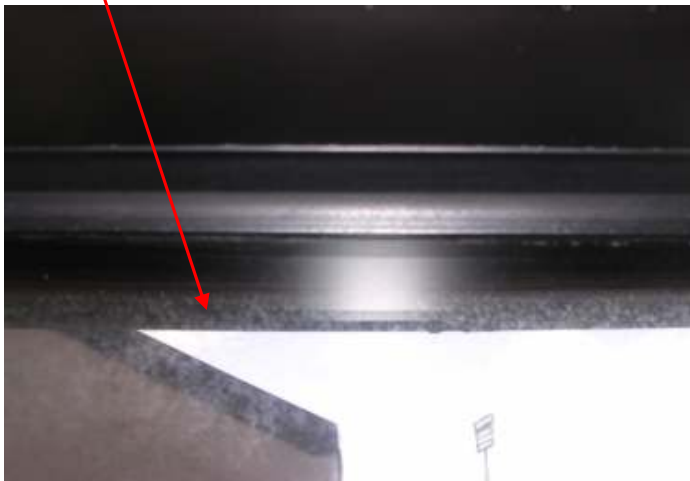
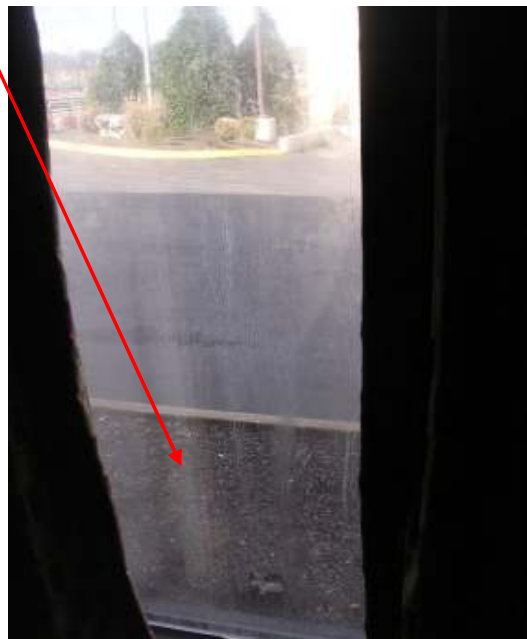
Approximately 25% of the windows have failed seals causing cloudy internal panes. Others show signs of beginning to have this staining.

Another 25% of the windows, besides the windows that have the obvious cloudiness throughout the window, have areas near the top edge that are starting to show that the seal has failed.

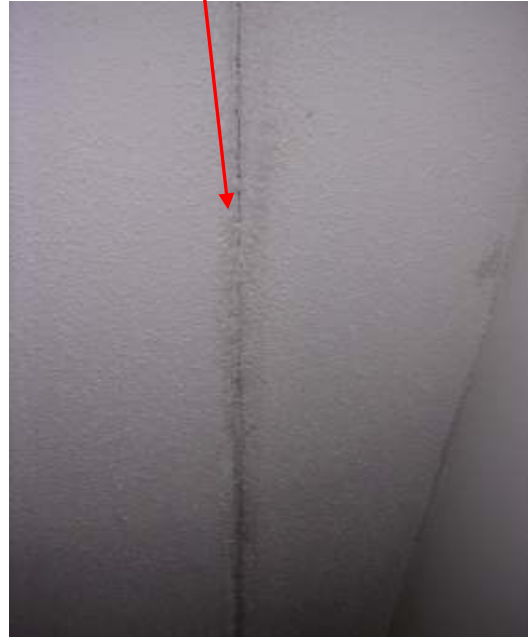
- 227 stain and chip above the door
- 228 stain outside wall at top edge
- 228 inside walls wheelchair damage
- 306 outside wall damaged from furniture
- 308 outside wall damage near floor

- 320 damage above headboard

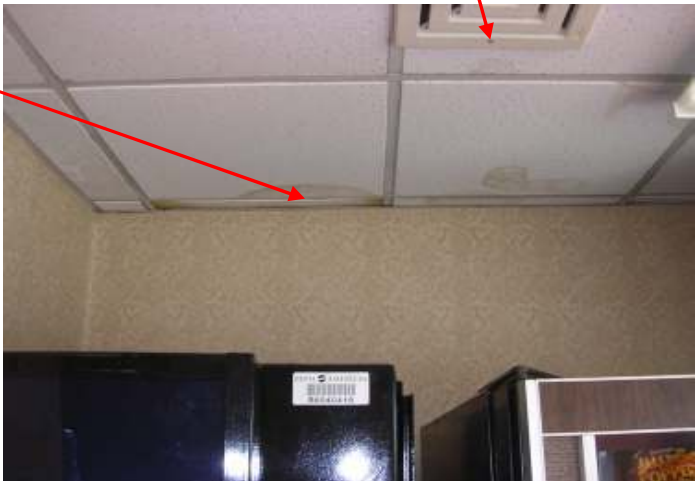
Suspended ceiling stained above the ice machine.

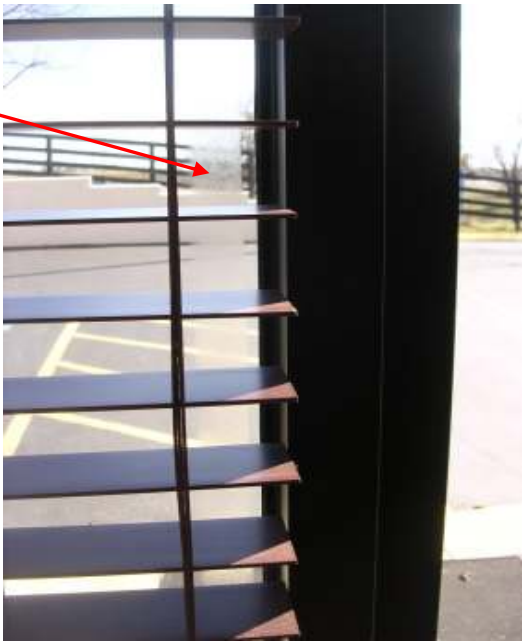
Rear window next to exit door frosted.

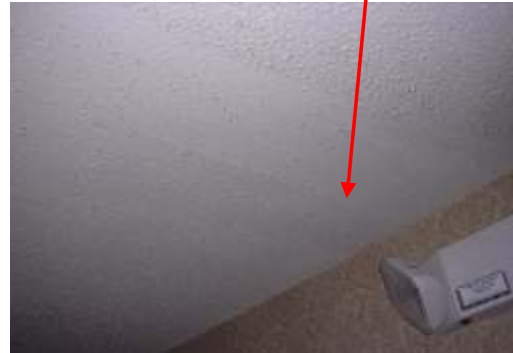
<b>Condition:</b>	<b>Items:</b>	
<b>Conditional</b>	<b>Ceiling:</b>	Drywall texture. Many joints in hallway showing cracks.
Functional	<b>Walls:</b>	Wallpaper
Functional	<b>Floor:</b>	Tile/carpet
Functional	<b>Exit Doors:</b>	Metal stairway doors.
Functional	<b>Electrical:</b>	Vending area 120vac.
Functional	<b>HVAC Source:</b>	Left half-left rooftop unit. Right half-right rooftop unit.
Functional	<b>Ventilation:</b>	Exhaust fan for ice/vending area operational
Functional	<b>Windows:</b>	Fixed
Functional	<b>Ice machine:</b>	Adequate
Functional	<b>Drain:</b>	Adequate
Functional	<b>Coke machine:</b>	Functioning
Functional	<b>Vending PTAC:</b>	Adequate

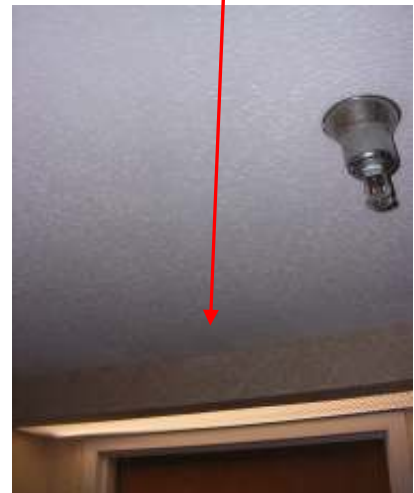
<b>Condition:</b>	<b>Items:</b>	
<b>Conditional</b>	<b>Ceiling:</b>	Drywall texture. Most joints in hallway showing cracks.
Functional	<b>Walls:</b>	Wallpaper
Functional	<b>Floor:</b>	Tile/carpet
Functional	<b>Exit Doors:</b>	Metal stairway doors.
Functional	<b>Electrical:</b>	Vending area 120vac.
Functional	<b>HVAC Source:</b>	Left half-left rooftop unit. Right half-right rooftop unit.
Functional	<b>Ventilation:</b>	Exhaust fan for ice/vending area operational
Functional	<b>Windows:</b>	Fixed
Functional	<b>Ice machine:</b>	Adequate
Functional	<b>Drain:</b>	Adequate
Functional	<b>Coke machine:</b>	Functioning
Functional	<b>Vending PTAC:</b>	Adequate

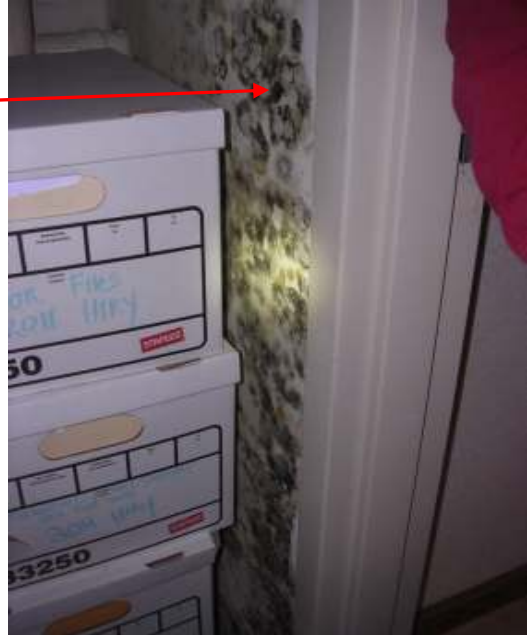
File storage wall moldy.

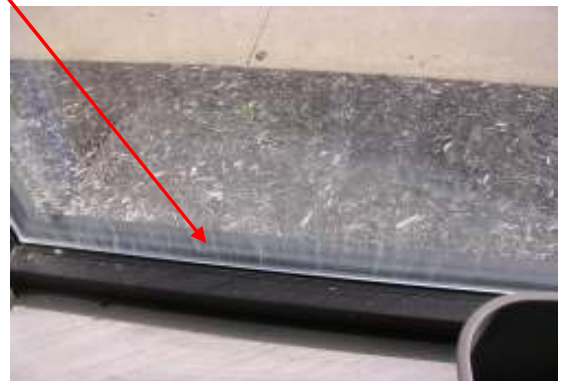
<b>Condition:</b>	<b>Items:</b>	
Functional	<b>Ceiling:</b>	Concrete.
Functional	<b>Walls:</b>	Drywall/paint.
Functional	<b>Floor:</b>	Concrete
Functional	<b>Exit Doors:</b>	Metal doors.
Functional	<b>Electrical:</b>	120vac outlets. Main electrical room.
Functional	<b>PTAC:</b>	Adequate
<b>Conditional</b>	<b>Windows:</b>	Window frosted and cloudy.

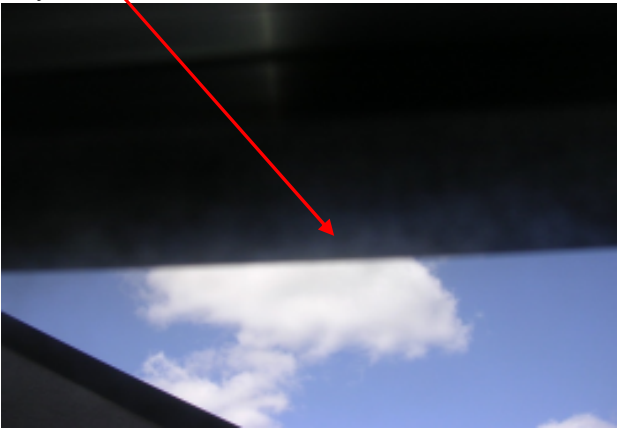
<b>Condition:</b>	<b>Items:</b>	
Functional	<b>Ceiling:</b>	Suspended ceiling
Functional	<b>Walls:</b>	Wallpaper
Functional	<b>Floor:</b>	Tile
Functional	<b>Exit Doors:</b>	Metal doors.
Functional	<b>Electrical:</b>	120vac.
Functional	<b>PTAC:</b>	Adequate
<b>Conditional</b>	<b>Windows:</b>	Window stained and cloudy.
Functional	<b>Elliptical:</b>	Adequate
Functional	<b>Bicycle:</b>	Adequate
Functional	<b>Treadmill</b>	Adequate

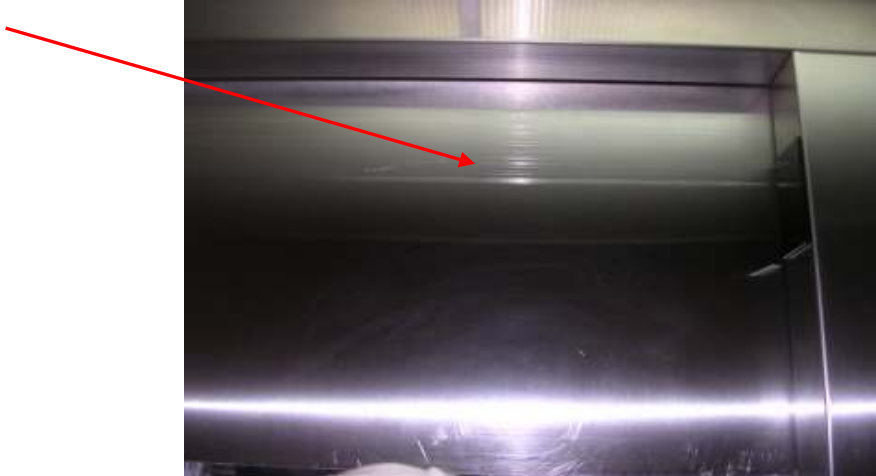
Inside door scratched.

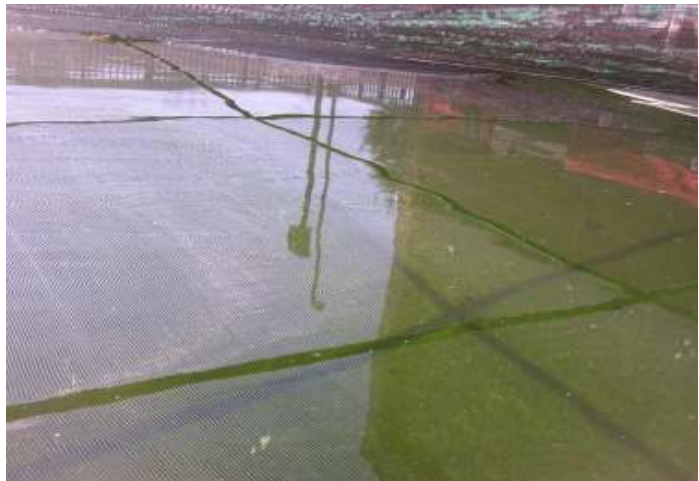
<b>Condition:</b>	<b>Items:</b>	Pool shut down for the winter and covered.
<b>Defective</b>	<b>Water condition:</b>	Mold growing on all walls. If the water was treated properly at winterizing, the water would not have allowed this amount of growth of mold.
<b>Defective</b>	<b>Pool siding condition:</b>	Concrete. I could not evaluate the pool surface due to the mold growth that was very thick. Charlie Long stated the pool siding was in very poor condition, with chipped paint/covering throughout the pool.
Functional	<b>Pump condition:</b>	Dayton 1 HP. Appears adequate
<b>Defective</b>	<b>Pool light:</b>	Reported by Charlie Long as not working.
NI	<b>Filter:</b>	Sand. Backwash instructions should be modified or generated. I do not feel this was being performed correctly.
<b>Defective</b>	<b>Electrical:</b>	Pump electrical likely ok. Pool building GFCI exterior outlet did not trip when tested.

This is a picture from between the pool cover looking down at the surface of the water. Mold is growing on all the walls in a thick manner.
