B and B Inspections

Report

October 8, 2013

Address
South Central, Ky.

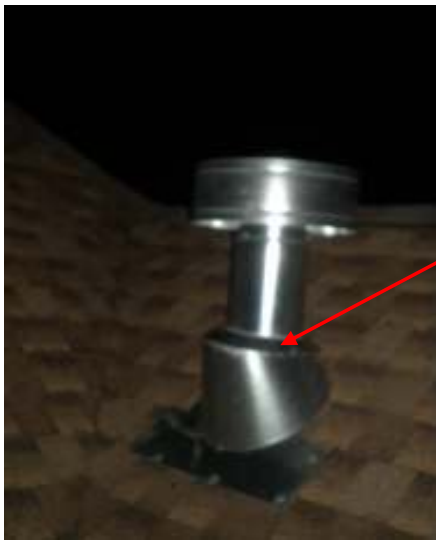
Stove vent installed in a sloppy manner.

Roof Flashing: Stove vent installed in a sloppy manner.
Pieces separating. Water will come into the attic.
This should be repaired/replaced, made watertight.

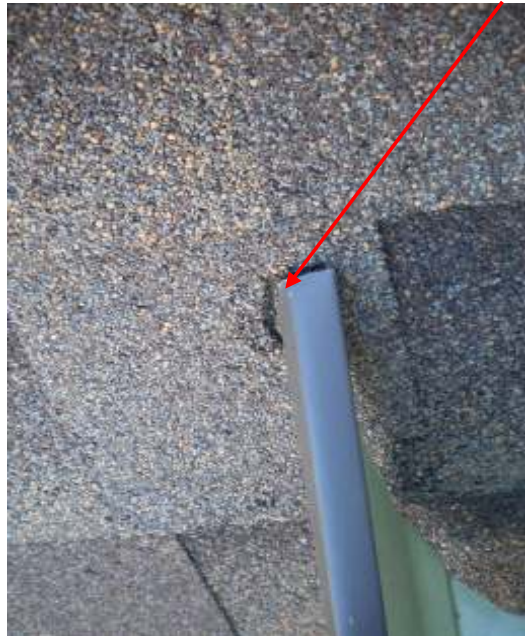
Shingles being cut by gutter on back porch.
Gutter cutting shingles both ends on back porch.

- Roof covering:** Shingles being cut by gutter on back porch.
- Gutters/downspouts:** Gutter cutting shingles both ends on back porch.
The shingle should be repaired, and the gutter cut back, at both ends.

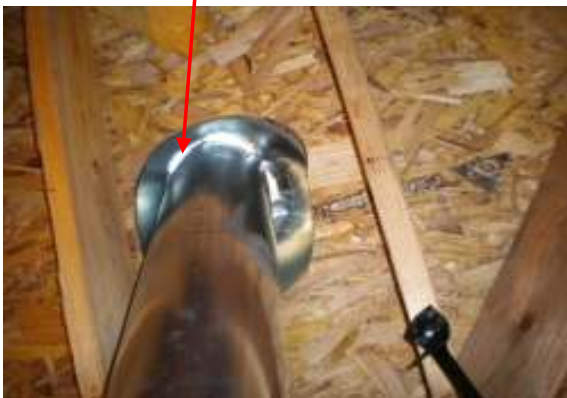
Pieces separating. Water will come into the attic.

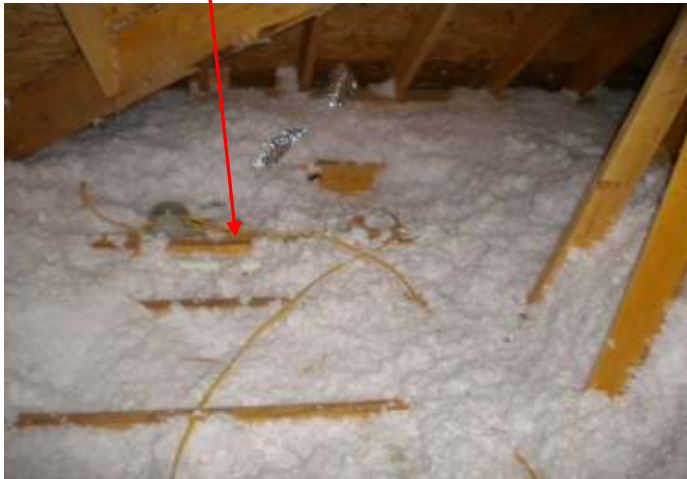
The insulation is trampled on the right middle side.

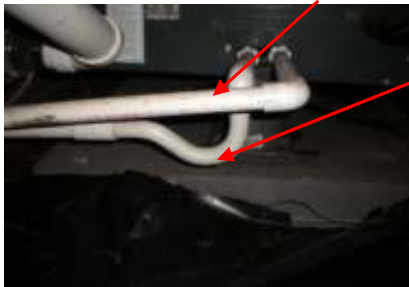
One drain did not have air trap in the drain. One did have this trap.

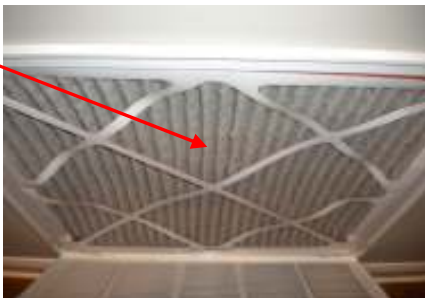
Dirty

- First floor HVAC Filter:** Dirty
This should be replaced.
- Second floor A/C System** The A/C system should achieve 15-20 degrees differential between the supply and return registers. This unit only had 6F differential.
An HVAC person should test this. Likely freon is needed. Should look for leaks.
The condensation issue for the first floor unit should be looked at also. See Defective Summary.
The moisture buildup under the first floor unit outside in the summer indicates the first floor unit outside unit should be also evaluated by an HVAC person.

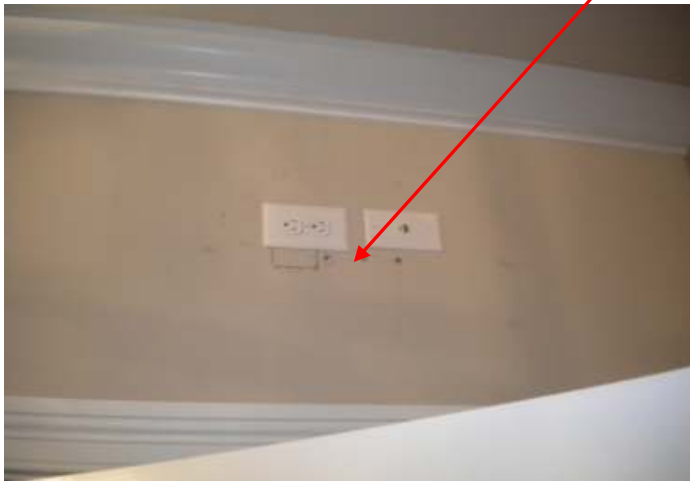
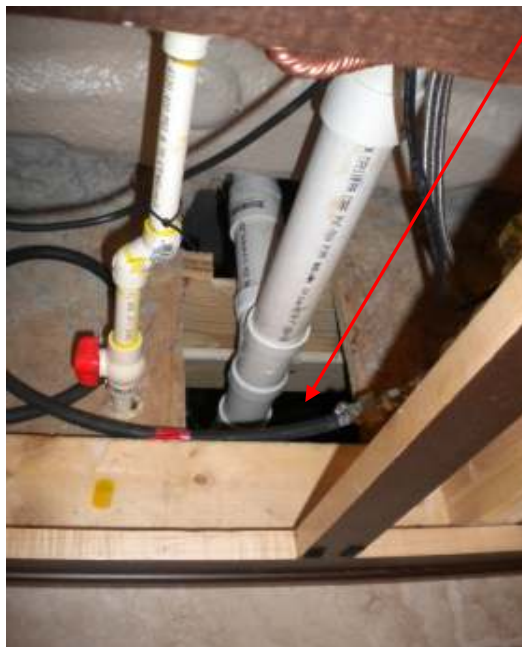
Unfinished work for outlet and cable above toilet door.

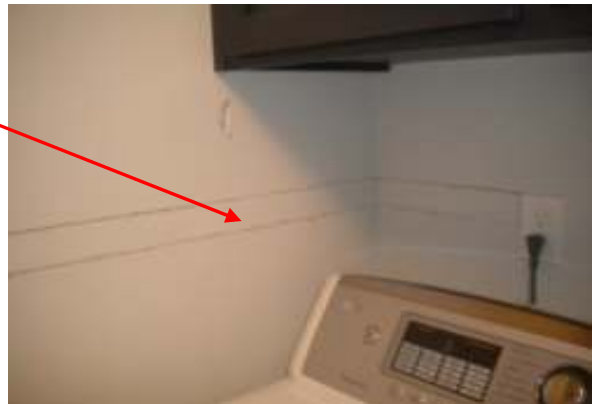
Unfinished work for outlet.

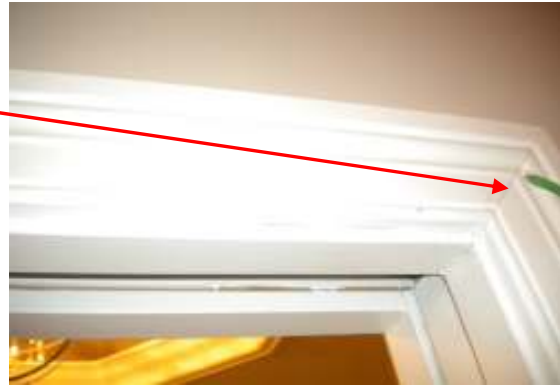
Master bedroom closet unfinished door molding.

- Kitchen Sink/Basin:** Metal. Loose drain fitting.
This should be secured before leaks develop.
- Closets:** Master bedroom closet unfinished door molding.
This should be finished.

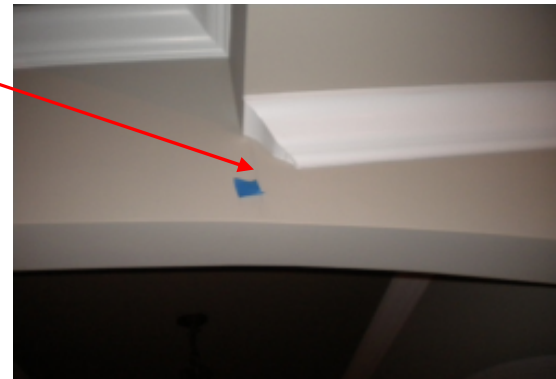
One crack in curved doorway from living room.

- Walls:** Drywall/paint. One crack in curved doorway from living room.
This should be repaired.
- Doors:** Door to stairway not able to close.
This should be repaired.

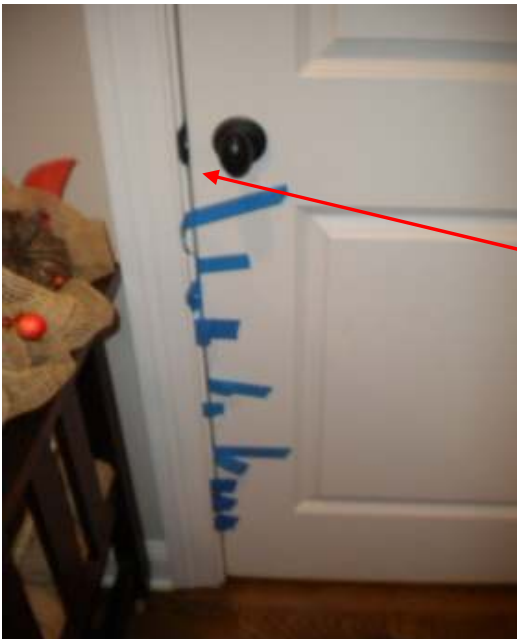
Door to stairway not able to close.

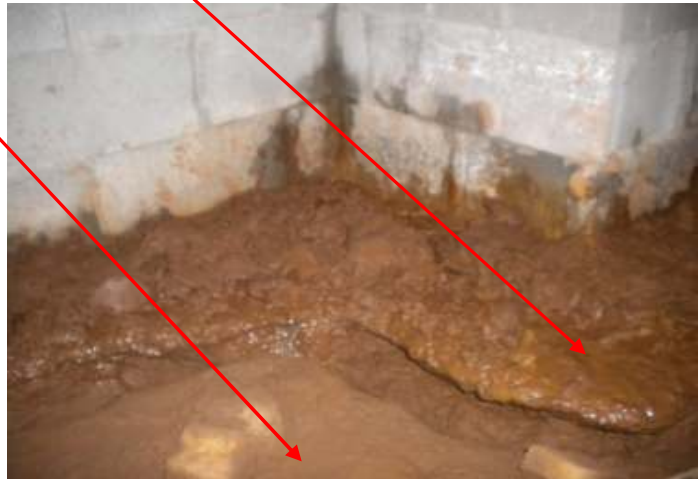
The front side, more on the right side, was wet and had standing water.

Sump pump likely necessary along the front edge.

**The source of the water needs to be proven that it is not from the underground drainage from the underground drains for the downspouts on the front of the house.
I feel water should be ran in these downspouts for extended periods, one at a time, monitoring any increase in water in the crawlspace. If the water level increases, the underground drain line needs to be repaired and/or taken further from the house.
If the water does not increase with testing of the downspouts, then a sump pump is likely needed.**

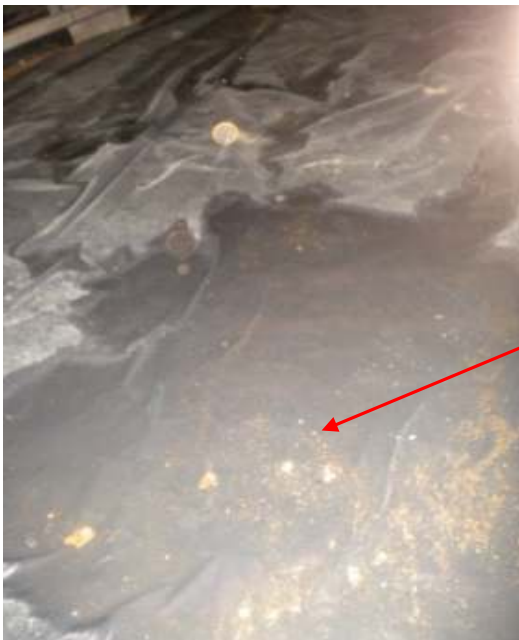
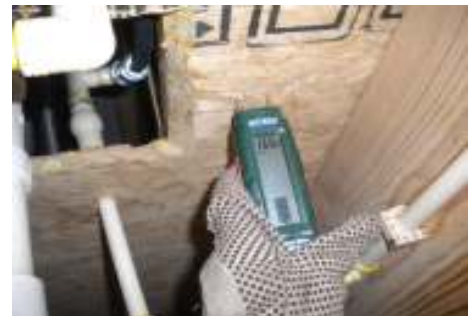
The middle of the crawlspace above the vapor barrier, likely coming from the condensate in the ductwork.

Crawlspace Moisture: Moisture in two areas. The middle of the crawlspace above the vapor barrier, likely coming from the condensate in the ductwork. See above.
The front side, more on the right side, was wet and had standing water.
