B and B Inspections

December 10, 2012

Report

Address
Any City, Ky.

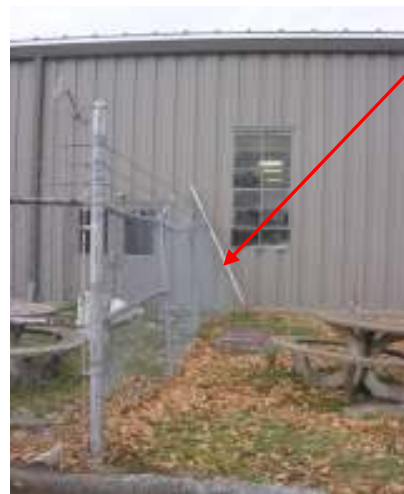
Left side demolition area has no smooth access to the
overhead door area. Does not drain.

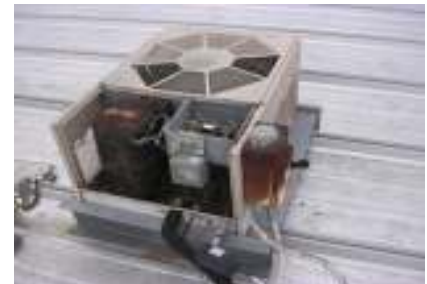
Items:
Heat Operation: Not found. Likely abandoned and replaced with unit D4.
A/C System: Not found
Condensate Removal: Not found
Thermostat: Not found
Flue Pipe: Not found
Flue Lines: Not found
Filter: Not found

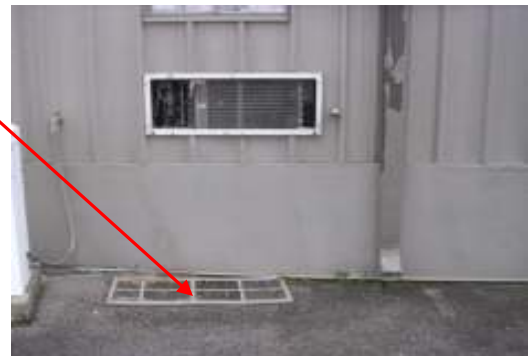
Functional **Condensate Removal:** Within unit.
Functional **Thermostat:** On unit
NP **Flue Pipe:** NP
NP **Flue Lines:** NP
NP **Filter:** NP. This is typical for this type.
Conditional **Misc.:** Cover off outside coils.

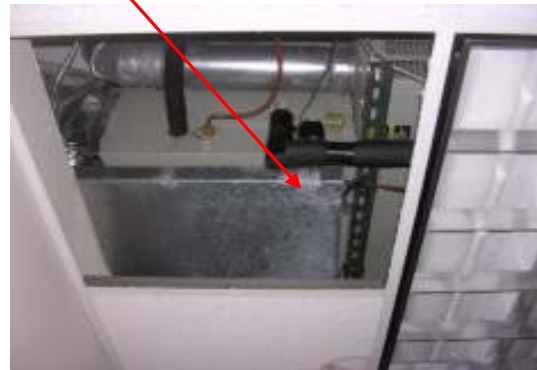
Condensate Removal: PVC to drain. Leak apparent. Ceiling in pieces below drain.
Thermostat: 2nd floor conference room front side
Flue Pipe: Metal
Flue Lines: Metal
Filter: Clean

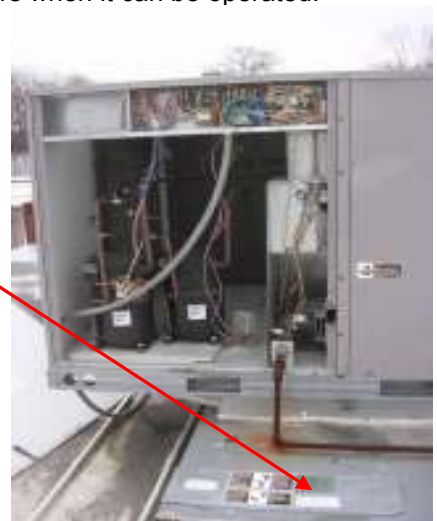
Condition:	Items:	
Functional	Heat Operation:	Adequate. This unit could maintain normal setpoints of the thermostat.
NI	A/C System	The A/C system should not be turned on until it has been higher than 65F for 24 hours. This should be checked for 15-20F differential between the supply and return registers when it can be operated.
Functional	Condensate Removal:	PVC to drain.
Functional	Thermostat:	Old office cad room.
Functional	Flue Pipe:	Metal
Functional	Flue Lines:	Metal
NI	Filter:	Likely rooftop.
Defective	Misc.:	Covers off of rooftop unit.

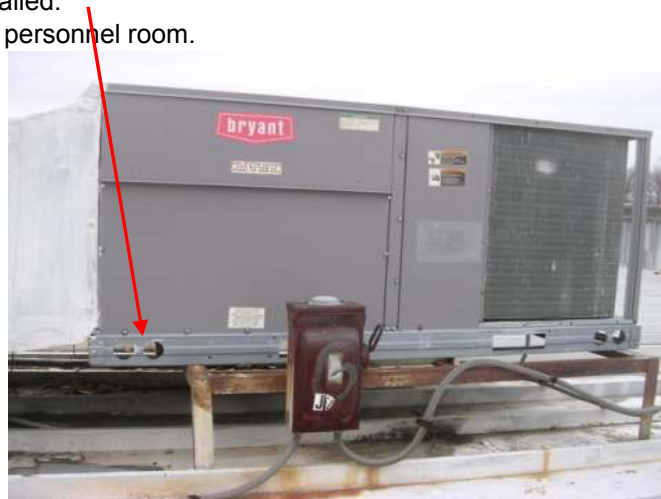
Condensate Removal: No drain line is installed.
Thermostat: HR access to plant personnel room.
Flue Pipe: Metal
Flue Lines: Metal
Filter: NI

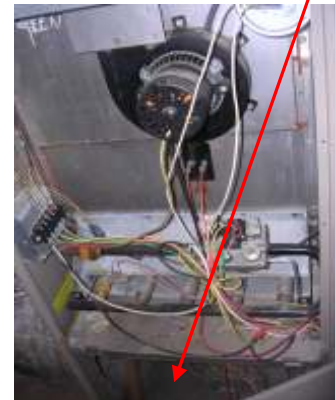
Condition:	Items:	
Defective	Heat Operation:	Covers off of the heater manifold is keeping the unit from turning on.
NI	A/C System	The A/C system should not be turned on until it has been higher than 65F for 24 hours. This should be checked for 15-20F differential between the supply and return registers when it can be operated.
Functional	Condensate Removal:	PVC to outside.
Functional	Thermostat:	Sales area front left.
Functional	Flue Pipe:	Metal
Functional	Flue Lines:	Metal
Conditional	Filter:	Filter housing loose.

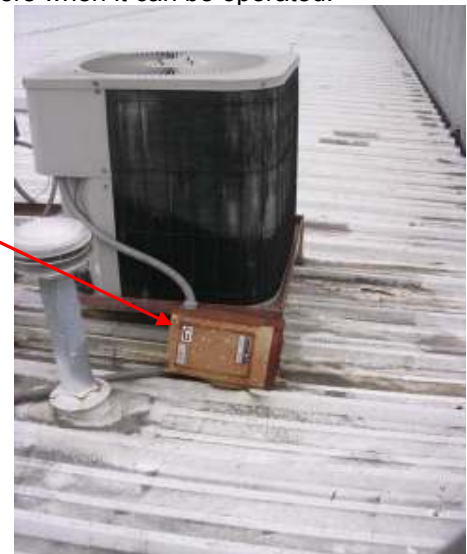
Condensate Removal: PVC to outside.
Thermostat: Sales area rear left.
Flue Pipe: Metal
Flue Lines: Metal
Filter: Adequate
Misc.: Disconnect not mounted upright or secured, but labeled vertically.

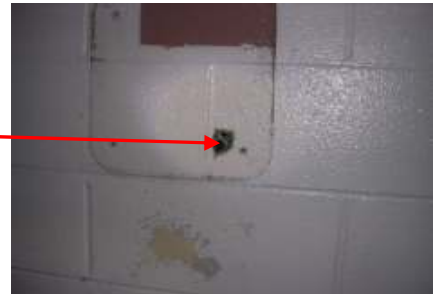
Rear warehouse break area - Women's Bath

Condition:	Items:	
Functional	Ceiling:	Metal
Functional	Walls:	Concrete block
Functional	Floor:	Coated concrete
Functional	Doors:	Metal
Functional	Sink/Basin:	Ceramic
Functional	Faucets/Traps:	Metal
Defective	Toilet:	5 Ceramic. 2nd and 4th ones loose from floor.
NP	Urinal:	NP
Functional	HVAC Source:	Central air vent
Functional	Ventilation:	Yes.
Defective	Electrical:	Blower removed with bare wires that were likely still powered.

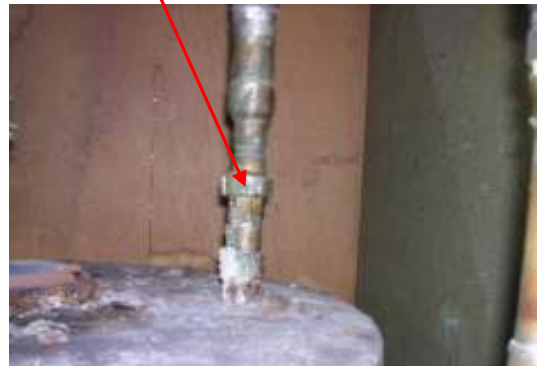
Front warehouse break area - Water Heater

Manufacturer:	A.O.smith	Location:	Front warehouse closet
	Fuel:	Electric		
Condition:	Items:			
Functional	State Inspection:	Inspection 12/1/94		
Defective	Operation:	Not on. Leaking feed water plumbing.		
NP	Flue Pipe:	NP		
Functional	TPRV and Drain Tube::	To floor		
Functional	Capacity:	76.8 gallon		
Defective	Circulation Pump:	Not functioning.		
Conditional	Sink in this area:	Cold water had no flow.

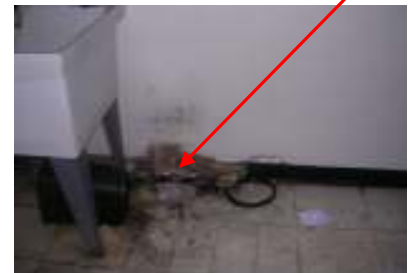
Sales Office - Sink

Condition:	Items:	
Defective	Faucets/Traps:	Metal/PVC. It appears the drain is leaking inside the wall behind the sink. Moisture meter was pegged-over 44%.
Functional	Sink/Basin:	Fiberglass

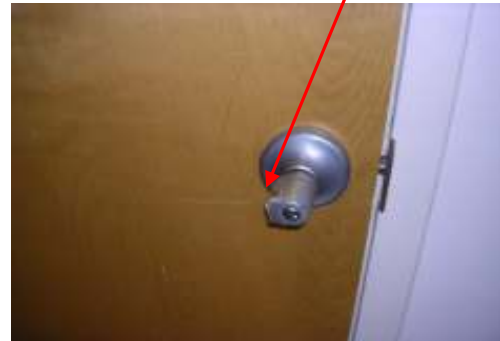
Lab Area

Condition:	Items:	
Functional	Ceiling:	Building steel structure/Suspended tiles
Functional	Walls:	Metal.
Functional	Floor:	Concrete
Conditional	Doors:	Wood and metal doors. 2 of 3 wood office doorknobs broke.
Functional	Windows:	Fixed and tilting
Conditional	Lights:	Many lights out.
Defective	Exhausts:	#2 Exhaust Fan has no controller. Did not work.

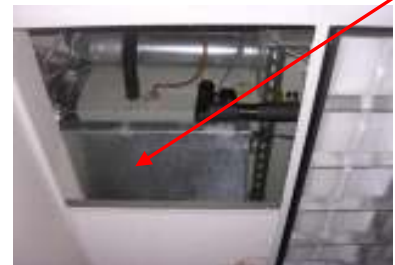
Engineering 1st Floor

Condition:	Items:	
Conditional	Ceiling:	Suspended tiles. Several stained tiles. Missing under former condensate leak.
Functional	Walls:	Drywall/paint.
Functional	Floor:	Carpet, some stains.
Functional	Doors:	Wood.
Functional	Windows:	Sliding
Conditional	Lights:	Many lights out.

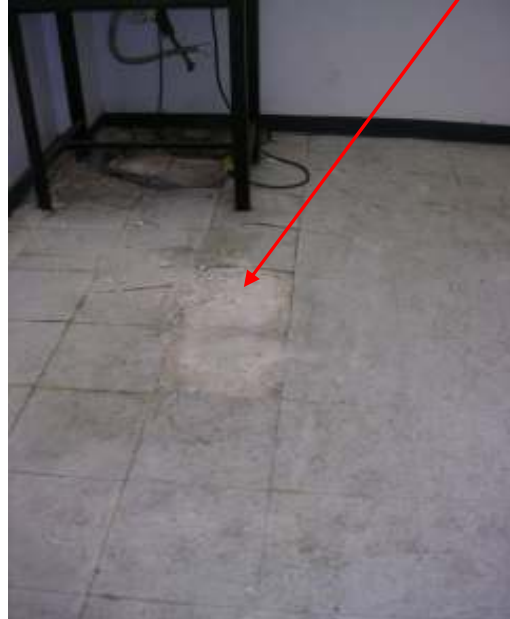
Front Warehouse Break room, Office area.

Condition:	Items:	
Defective	Ceiling:	Suspended tiles. Many stained tiles.
Functional	Walls:	Drywall/paint, concrete block.
Conditional	Floor:	Vinyl tile. Concrete under tile swelling under and near coke machine.
Functional	Doors:	Wood.
Functional	Windows:	Fixed.
Defective	Lights:	Many lights out.

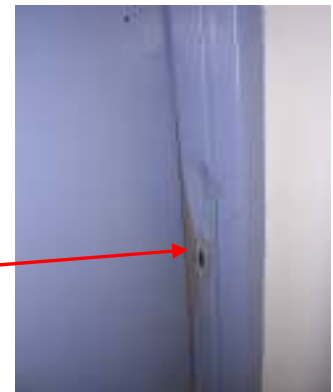
Front Warehouse Second Floor office area.

Condition:	Items:	
Defective	Ceiling:	Suspended tiles. Many stained tiles.
Functional	Walls:	Drywall/paint.
Functional	Floor:	Vinyl tile
Functional	Doors:	Wood.
Functional	Windows:	Fixed.
Defective	Lights:	Many lights out.
Defective	Exit Doors:	Several doors chained shut. Left side warehouse exit door break-in damage.

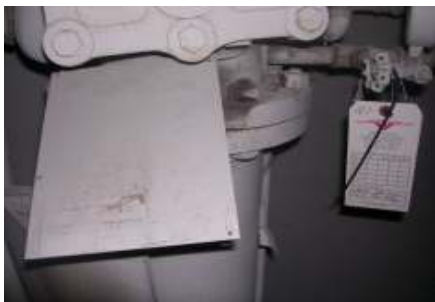
No spare sprinkler heads.
